R O C K M O R E
I N T E R N A T I O N A L

Failure Troubleshooting

DTH Drilling Tools - *Bits and Hammers* -

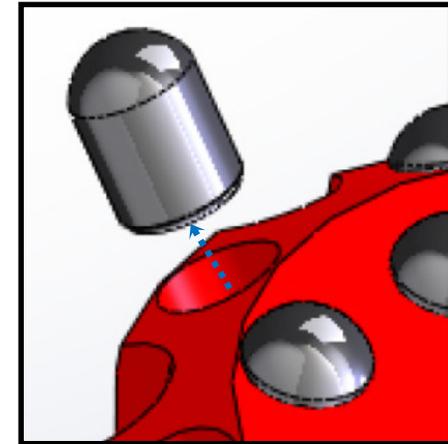
Failure: Carbide pop-out

- Excessive body wash
- Excessive bit body grinding
- Drilling in very soft or extremely abrasive conditions
- Drilling in excessive unconsolidated rock
- Excessive energy produced by the piston
- Insufficient feed pressure
- Back hammering / dry firing

- Follow proper carbide sharpening procedures to avoid over grinding bit body; replace worn out bits
- Adjust drilling parameters to rock conditions
- Adjust feed pressure to rock conditions
- Stop percussion until the bit is in full contact with rock

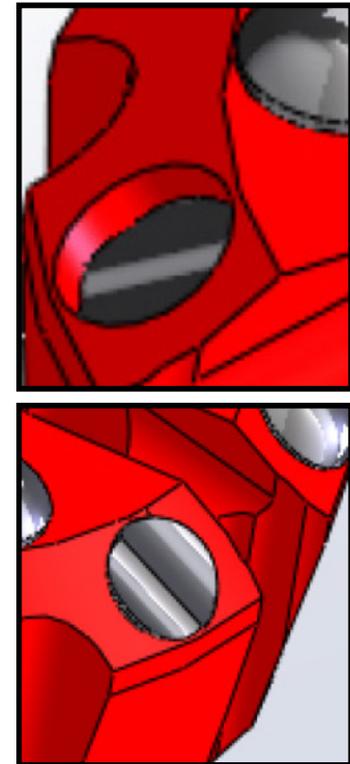
Carbide broken inside socket &
Top of carbide sheared off at body

- Over heating of the bit
- Drilling with flat carbides
- Forceful rotation against obstacles in rock

- Adjust rotation speed and other drilling parameters to rock conditions
- Sharpen dull carbides, following proper carbide sharpening procedures
- Adjust feed pressure to rock conditions; in difficult drilling conditions--such as loose or fractured material, or when encountering obstructions--use already damaged bits to avoid damaging bits in good condition

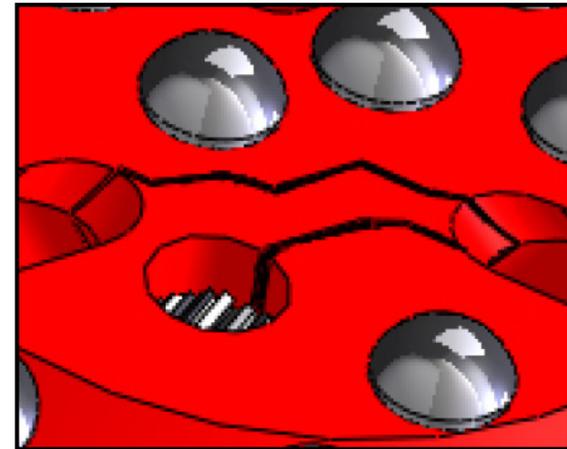
Crack on face between flushing holes, flushing hole and carbide, or between carbides

- Excessive feed force
- Drilling with flat carbides

- Adjust feed force to rock conditions
- Sharpen dull carbides, following proper carbide sharpening procedures

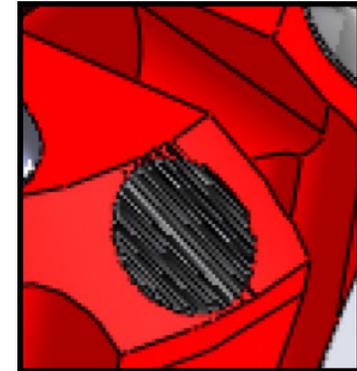
Top of carbide crushed down to level of body &
Carbide crushed inside body

- Over drilling in a non-abrasive rock, such as limestone
- Improper carbide grinding intervals
- Excessive carbide protrusion from poor grinding practices

- Inspect carbides frequently for snake skin wear pattern (see page 16)
- Shorten grinding intervals when drilling in non-abrasive rock
- Sharpen carbides when dull or micro cracks begin to form, following proper carbide sharpening procedures
- When sharpening carbides do not remove excessive body; carbides should not protrude more than 3/4 of the carbide diameter

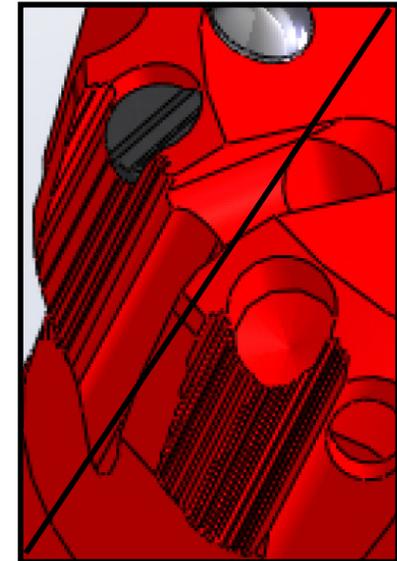
Carbide partially missing, surrounding matrix damaged & Carbide completely missing, surrounding matrix damaged

- Over drilling of bit
- Drilling with flat carbides
- Improper grinding intervals
- Drilling with a bit already missing carbide

- Inspect carbides more frequently
- Sharpen dull carbides, following proper carbide sharpening procedures
- Increase grinding intervals
- Discard and replace worn out or damaged bits

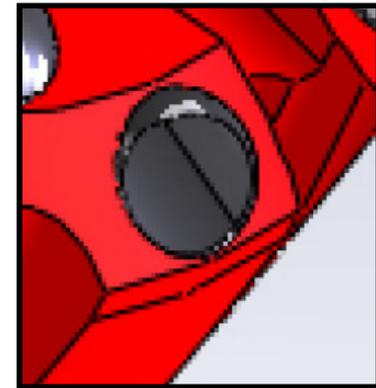
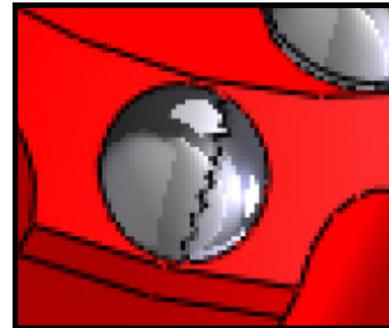
Failures: Carbide chipped & Carbide cracked

- Over drilling of bit
- Drilling in a non-abrasive rock
- Improper grinding intervals
- Carbide grade too hard for the rock condition
- Slow rotation and bit is not positioned into solid rock

- Inspect carbides frequently for snake skin wear pattern (see page 16)
- Sharpen carbides when dull or micro cracks begin to form, following proper carbide sharpening procedures
- Select bits with suitable carbide hardness for drilling application
- Do not start percussion until the bit is in full contact with rock

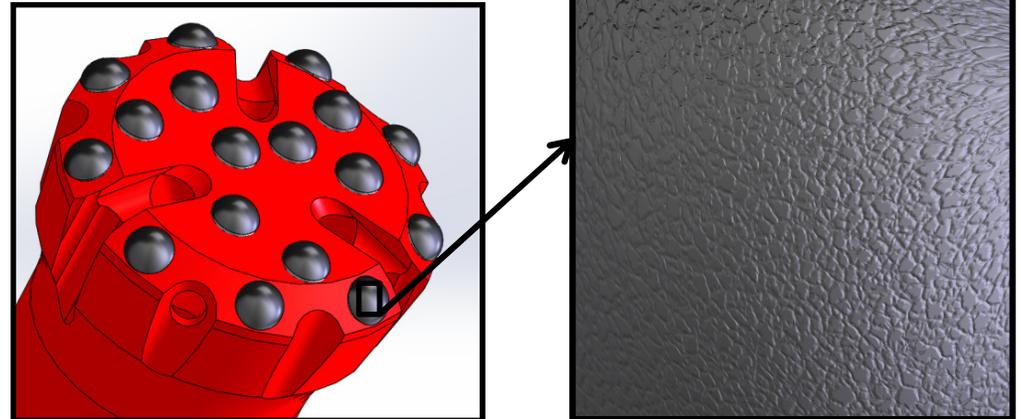
Problem: Carbide snake skin wear pattern *

- Drilling in a non-abrasive rock, such as limestone
- Improper carbide grinding intervals

* Snake skin is a wear pattern of micro cracks that develop from drilling fatigue in non-abrasive rock. The cracks will eventually penetrate deeper and cause large chunks to break away.

- Inspect carbides frequently
- Shorten grinding intervals when drilling in non-abrasive rock
- Sharpen carbides when dull or micro cracks begin to form, following proper carbide sharpening procedures

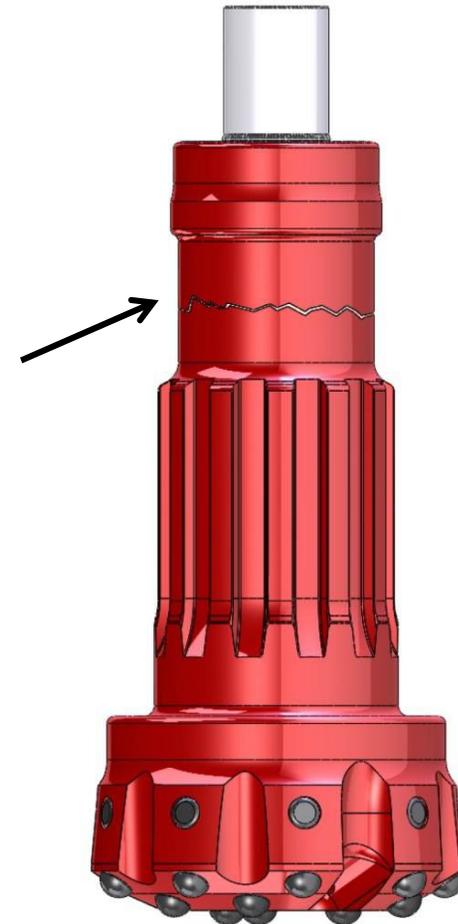
Failure:
Shank break across the retaining ring bearing surface

- Lack of lubrication
- Worn out bit retaining rings
- Worn out guide bushing (not applicable for Rockmore's ROK series DTH hammers)

- Use the correct type and quantity of hammer oil
- Inspect the condition of the bit, retaining rings, and guide bushing before drilling
- Replace worn out hammer components with new parts

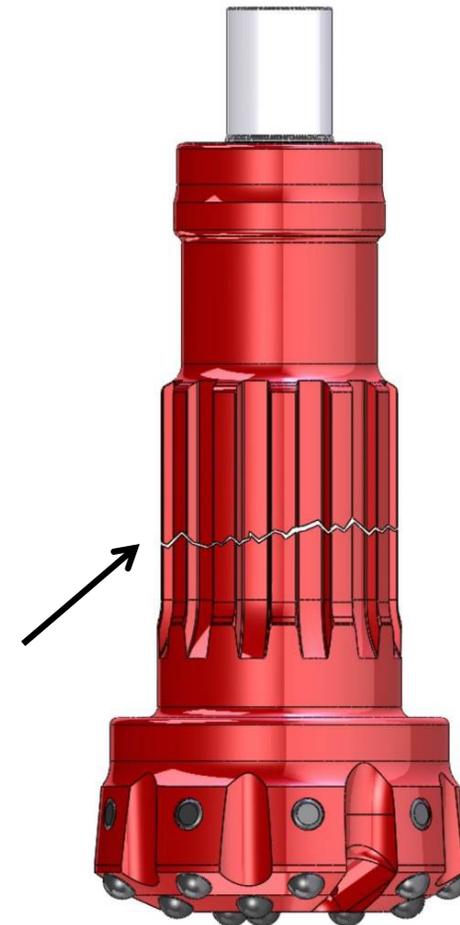
Failure: Shank break across the drive splines

- Oversized head diameter, in relation to DTH hammer diameter
- Excessive torque
- Worn out driver sub

- Adjust drill settings when using oversized drill bits
- Use a larger DTH hammer recommended for that diameter of bit
- Adjust torque to rock conditions
- Inspect the condition of the bit and driver sub before drilling
- Replace worn out hammer components with new parts

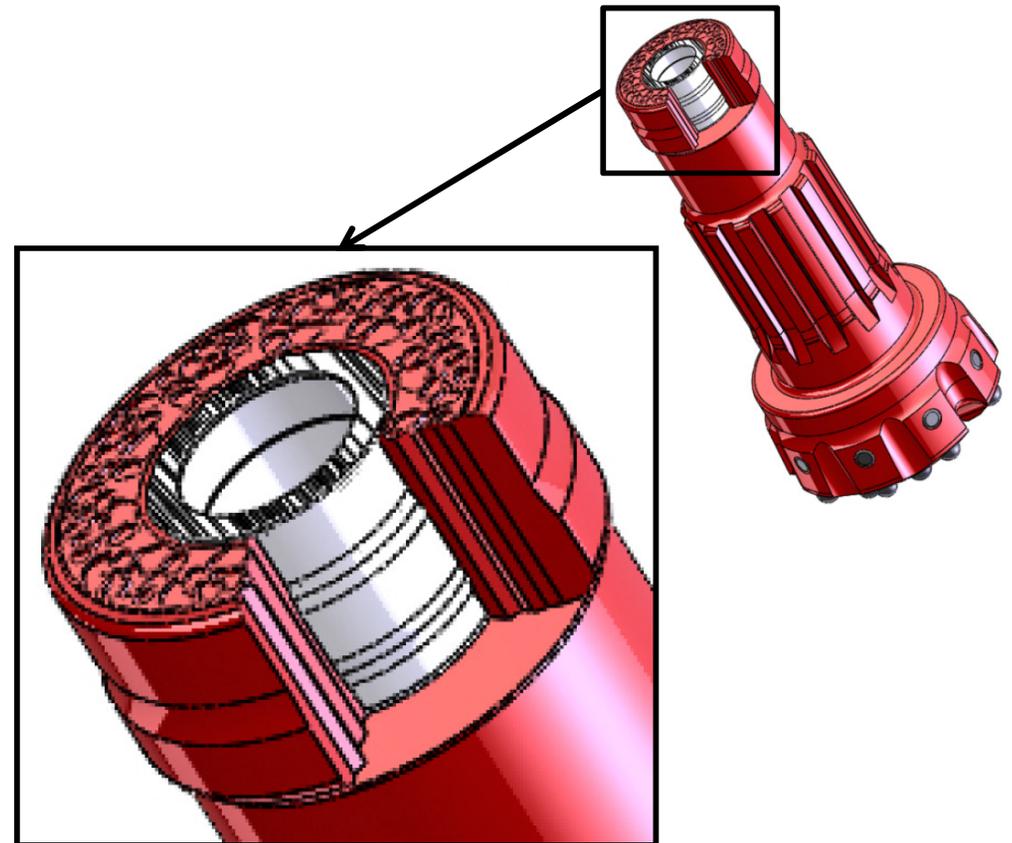
Failure: Broken piston striking face

- Worn out piston, bit retaining ring, or driver sub
- Worn out guide bushing (not applicable for Rockmore's ROK series DTH hammers)

- Inspect the condition of the piston, bit retaining rings, driver sub and guide bushing before drilling
- Replace worn out hammer components with new parts

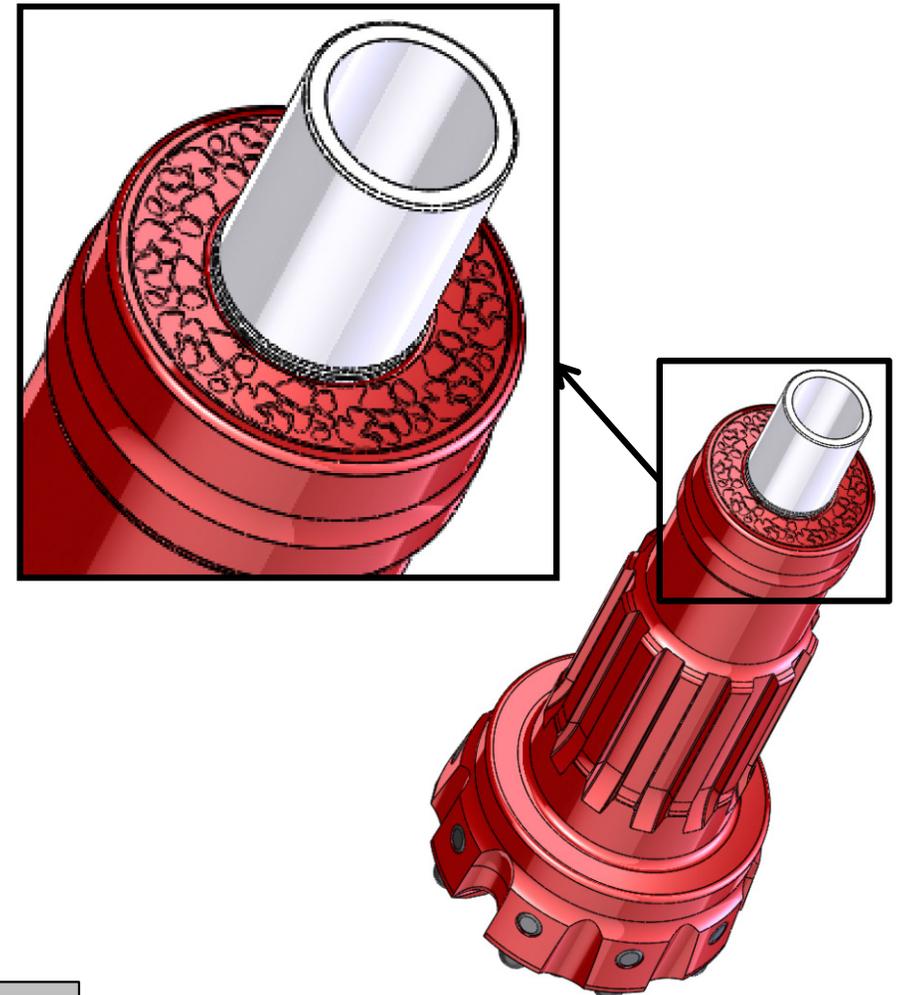
Problem: Piston striking face damage

- Insufficient lubrication
- Foreign material trapped between the bit and piston

- Use the manufacturer's recommended type and quantity of hammer oil
- Keep the hammer joints tight; and clean the driver sub, bit retaining ring, and drive splines regularly
- Inspect hammer check valve assembly for proper function

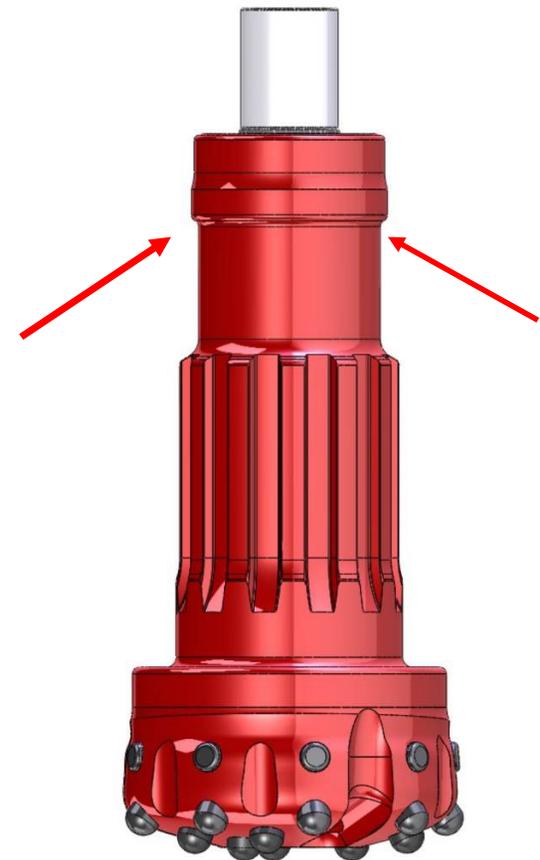
Problem: Bit Retaining Area Damage

- Drilling with loose Driver Sub
- Insufficient feed force; Bit out running hammer

- Apply proper torque on Driver Sub
- Increase feed force when drilling in soft and unconsolidated rock conditions

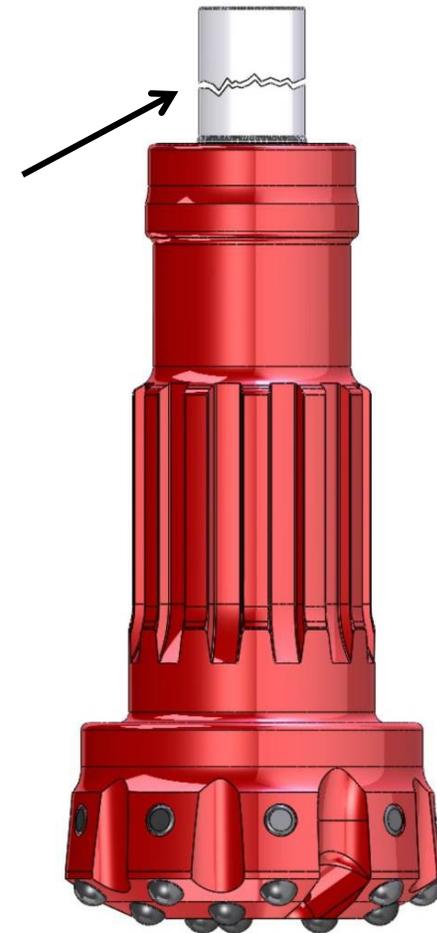
Failure: Broken blow tube / foot valve

- Worn out piston, drive splines, or driver sub
- Misalignment
- Lack of lubrication

- Inspect the condition of the piston, bit, and driver sub before drilling
- Replace worn out hammer components with new parts
- Use alignment tools and adjust drilling practices to achieve a straighter hole; use bits with concave face design
- Use the correct type and quantity of hammer oil

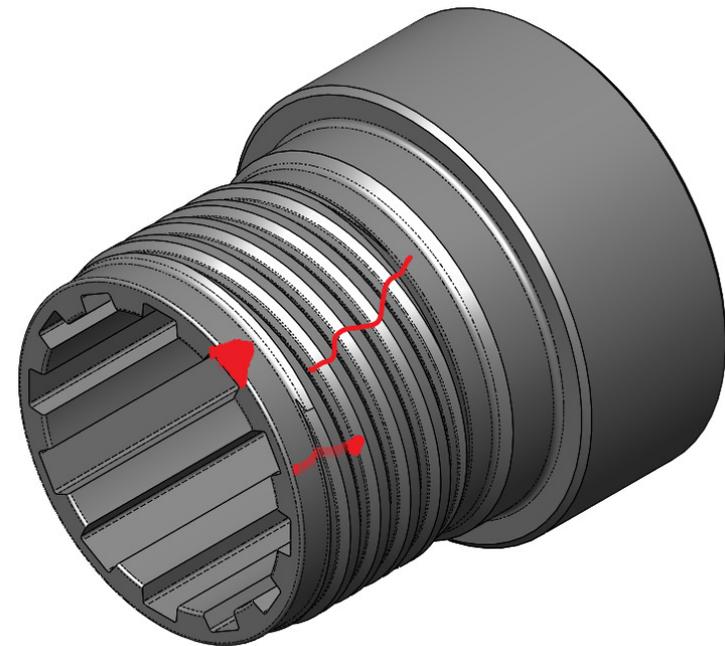
Failure: Broken driver sub

- Loose joint
- Gap between driver sub shoulder and wear sleeve
- Not enough feed pressure
- Lack of lubrication on threads

- Apply proper make-up torque
- Avoid hammering without rotation
- Increase feed force while drilling in soft and unconsolidated rock conditions
- Apply enough feed pressure
- Replace driver sub
- Apply proper type and quantity of grease to driver sub threads

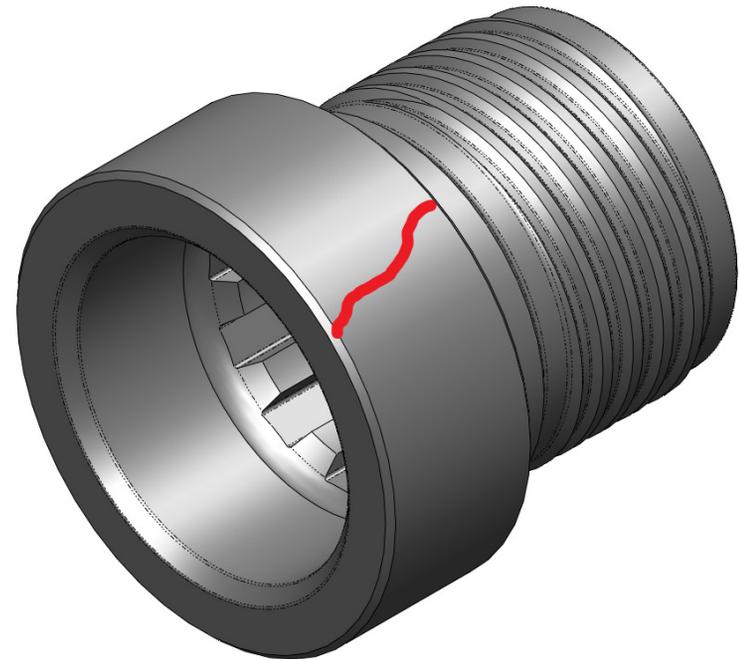
Failure: Cracked driver sub

- Abuse with sledge hammer

- Use tongs or chains to loosen the driver sub from wear sleeve

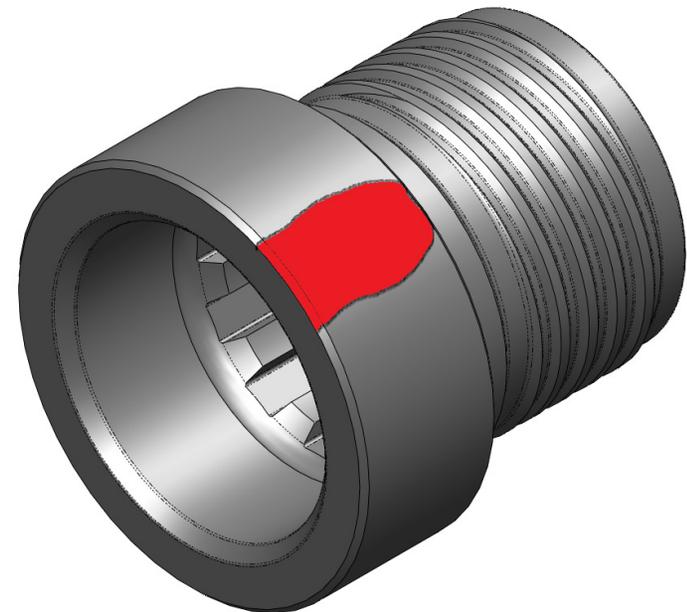
Failure:
Excessive driver sub wear

- Excessive wear on bit

- Reduce cuttings up hole velocity
- Replace worn bit
- Rotate driver sub frequently

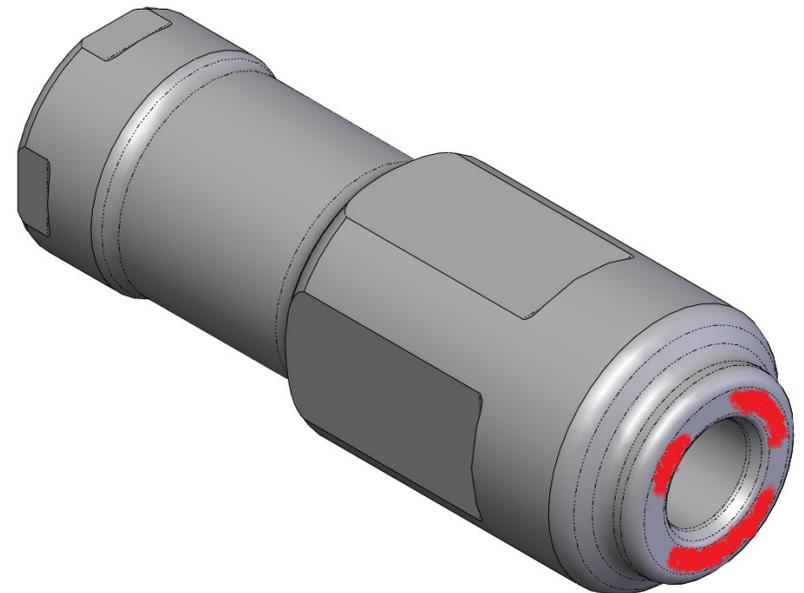
Failure:
Broken striking face

- Insufficient feed force
- Debris in hammer
- Check valve not working properly

- Increase feed force until reaching smooth rotation
- Inspect and clean hammer from particles
- Replace check valve

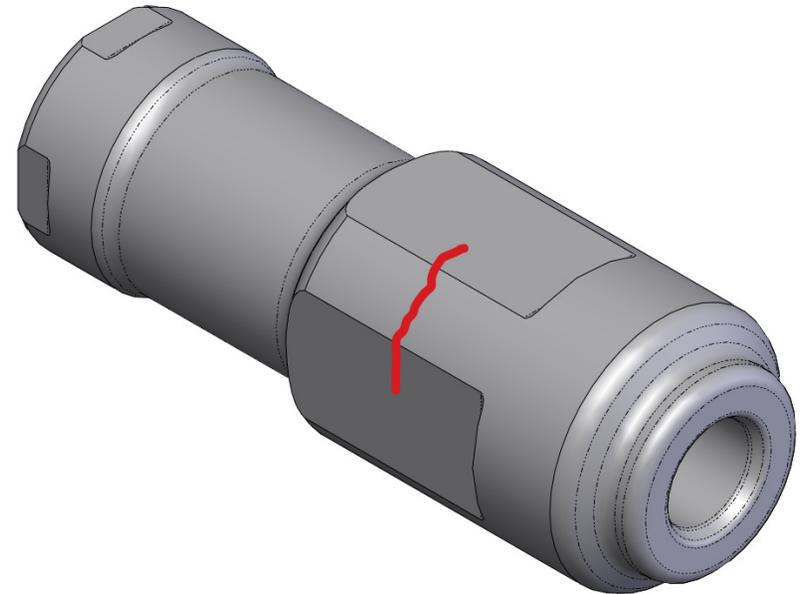
Failure: Piston cracked

- Lack of lubrication
- Wrenching on wrong location
- Getting stuck in hole
- Hole deviation

- Check lubrication system and ensure oil film is developed in bit flushing holes
- Use wrenching areas to avoid distorting wear sleeve
- Use water when stuck; friction can cause sleeve to distort

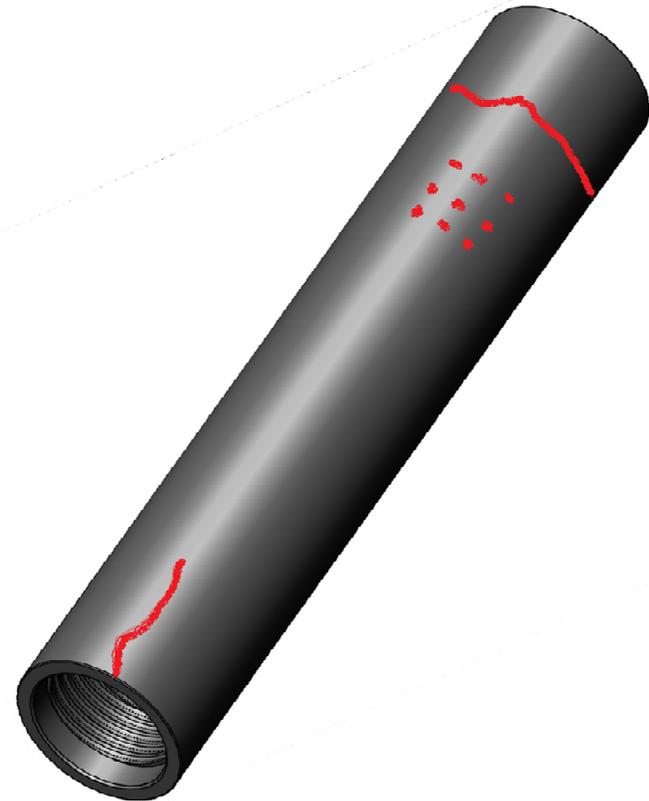
Failure: Cracked wear sleeve

- Gripping with jaw wrench on wrong location
- Worn wear sleeve
- Corrosion

- Use correct tong placements
- Replace wear sleeve when outside diameter reaches discard limit.
- Ensure pH neutral water; coat with corrosion protector when storing

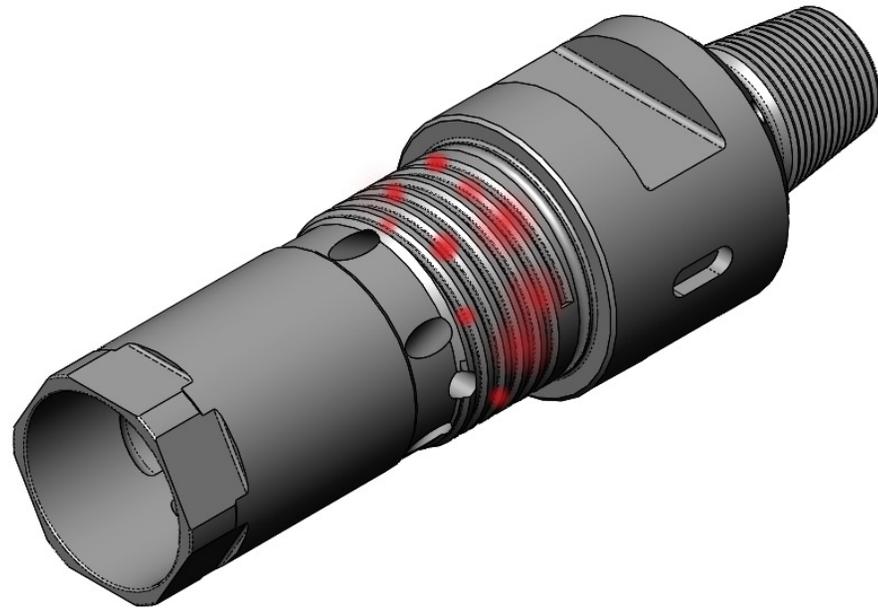
Failure:
Thread failure

- Corrosion at thread root

- Regular replacement of thread lubricant

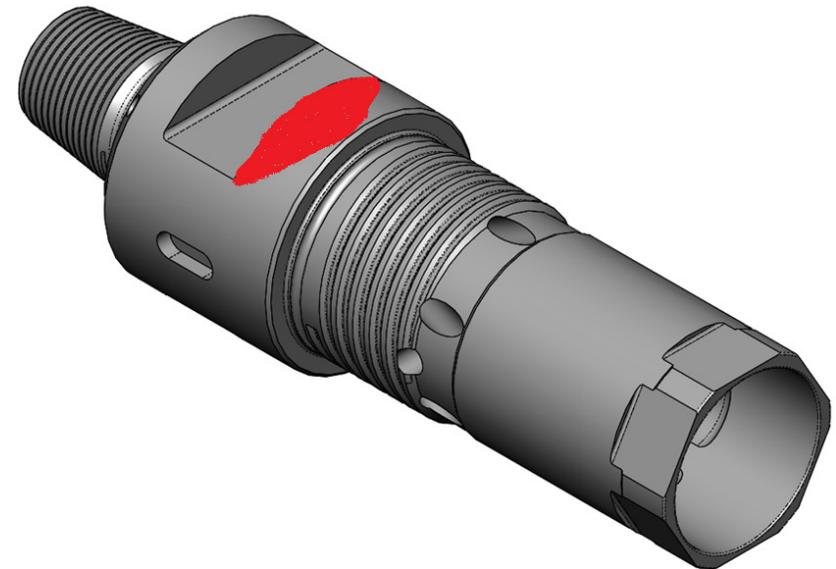
Failure: Broken Top Sub

- Improper torque between joints

- Apply minimum recommended torque

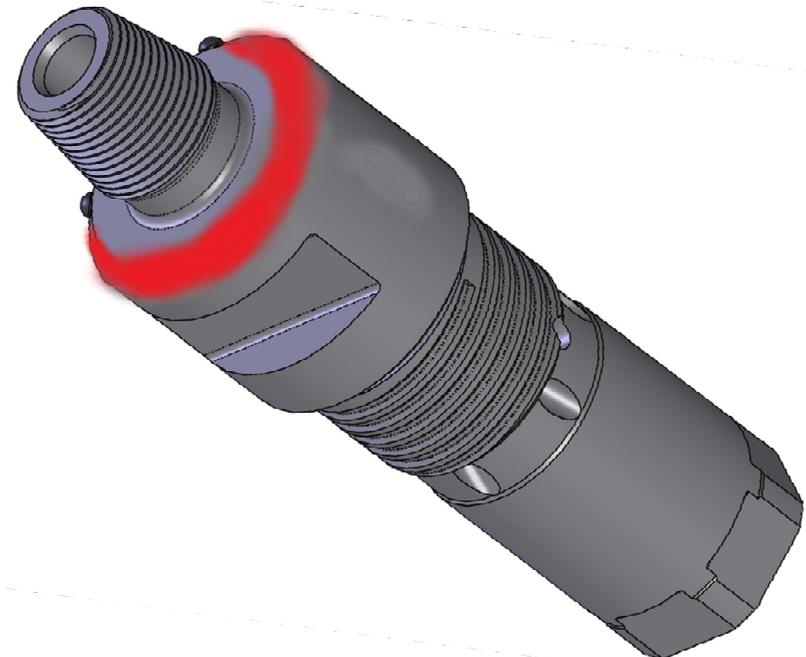
Failure: Missing reaming buttons

- Excessive top sub wear
- Getting stuck while drilling

- Adjust parameters to drilling conditions.
- On unconsolidated rock always use reaming buttons on top sub

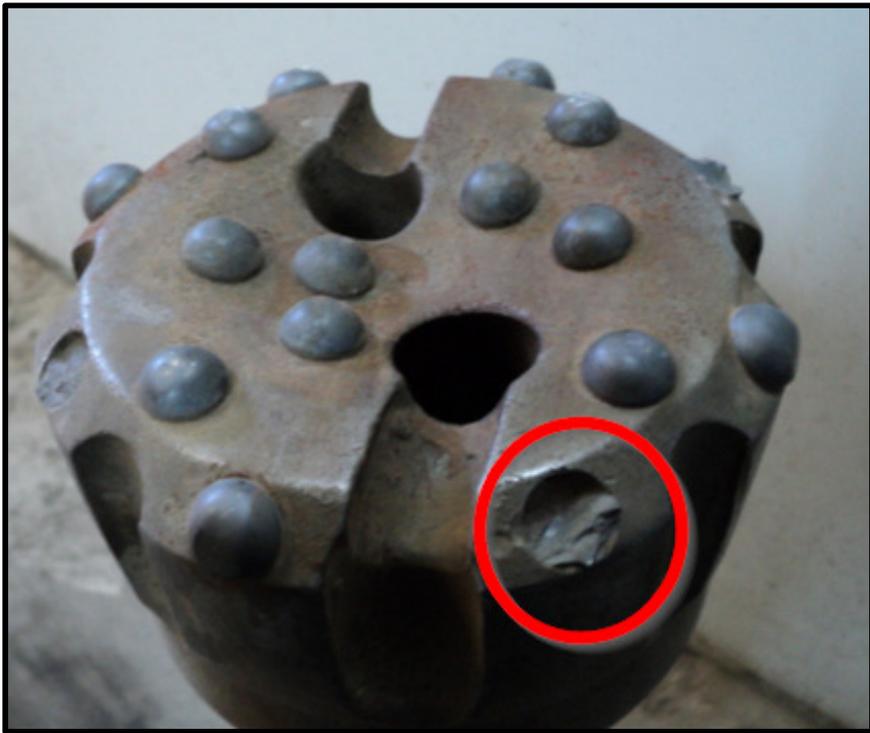
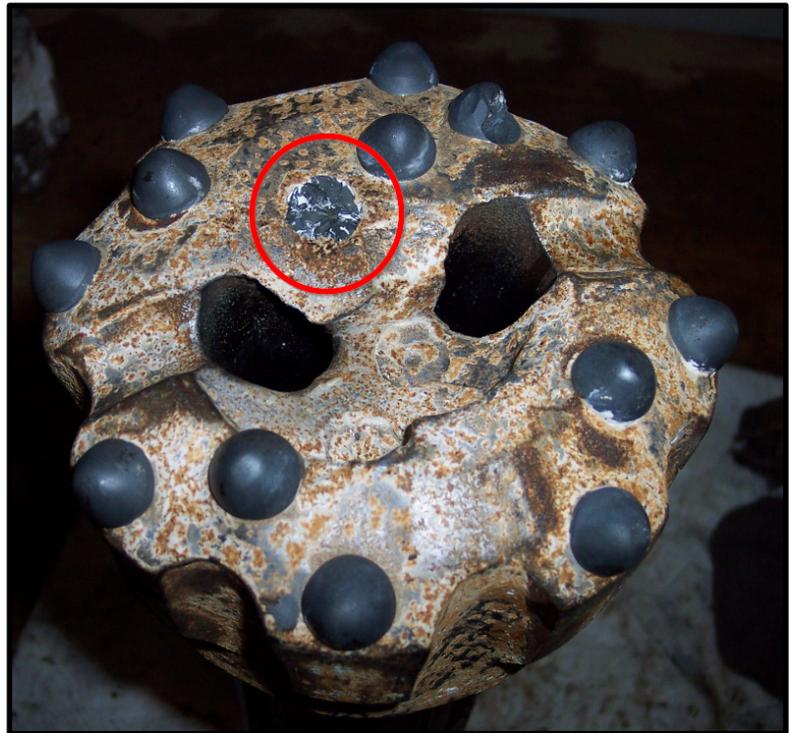
Failure: Broken carbide

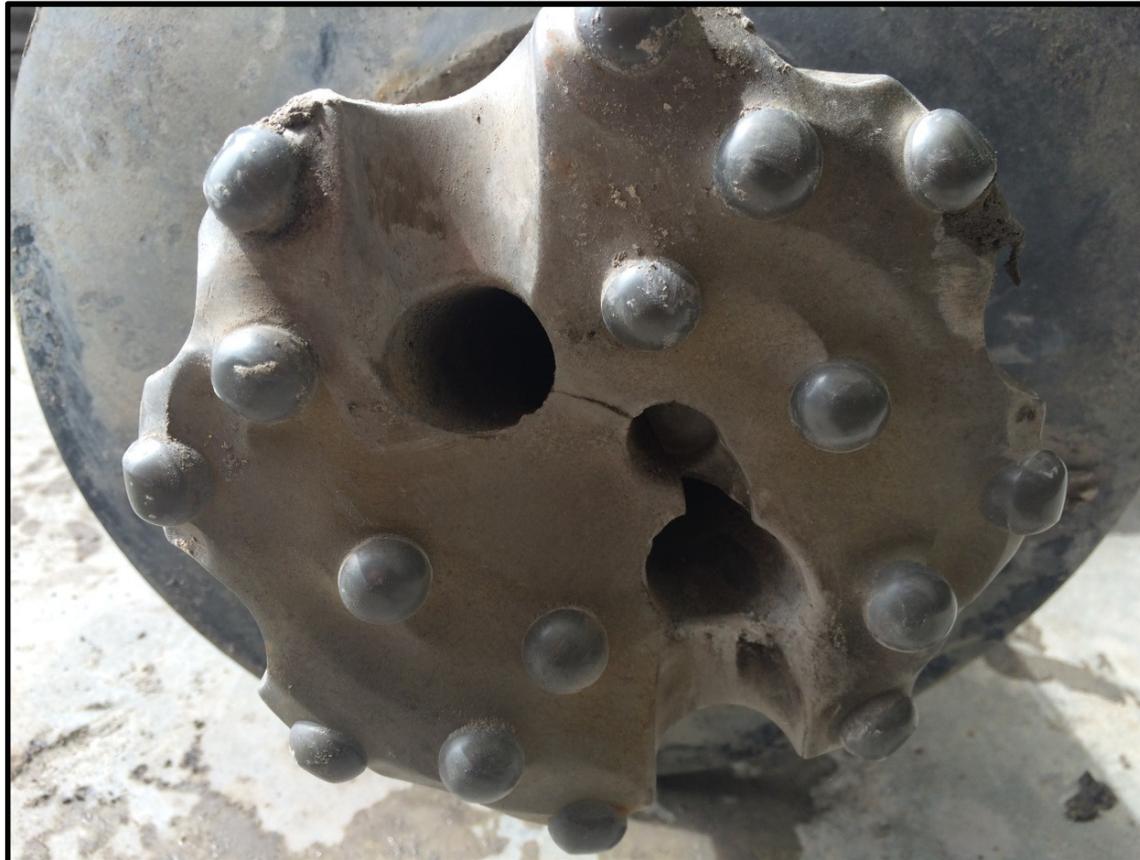
Failure: Crack between flushing holes

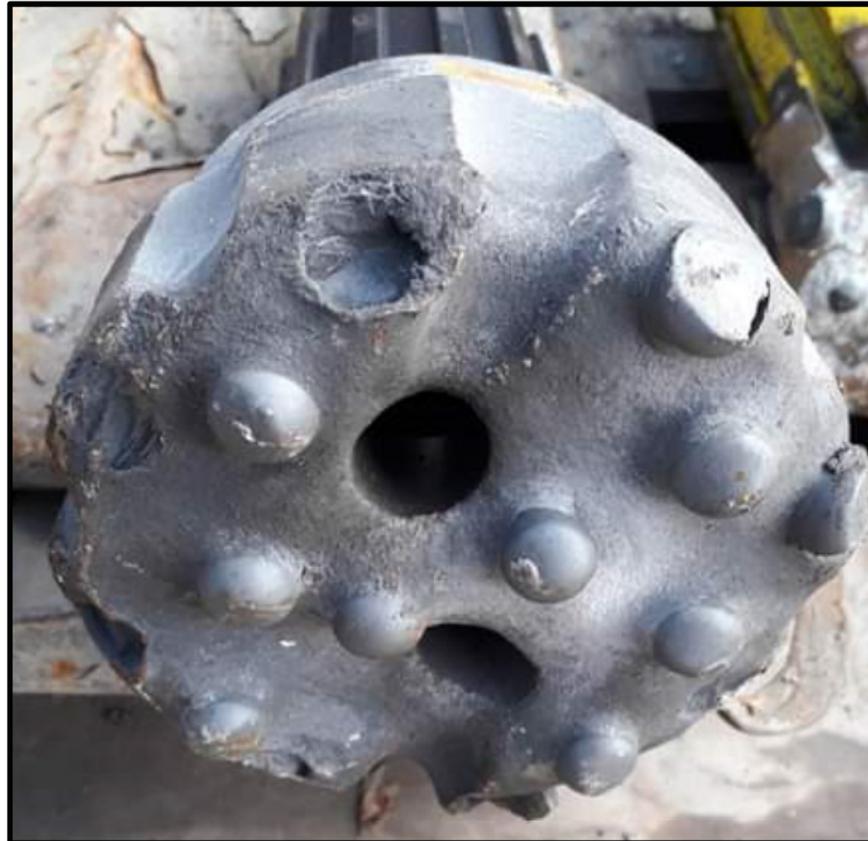
Failure: Broken carbide inside pocket

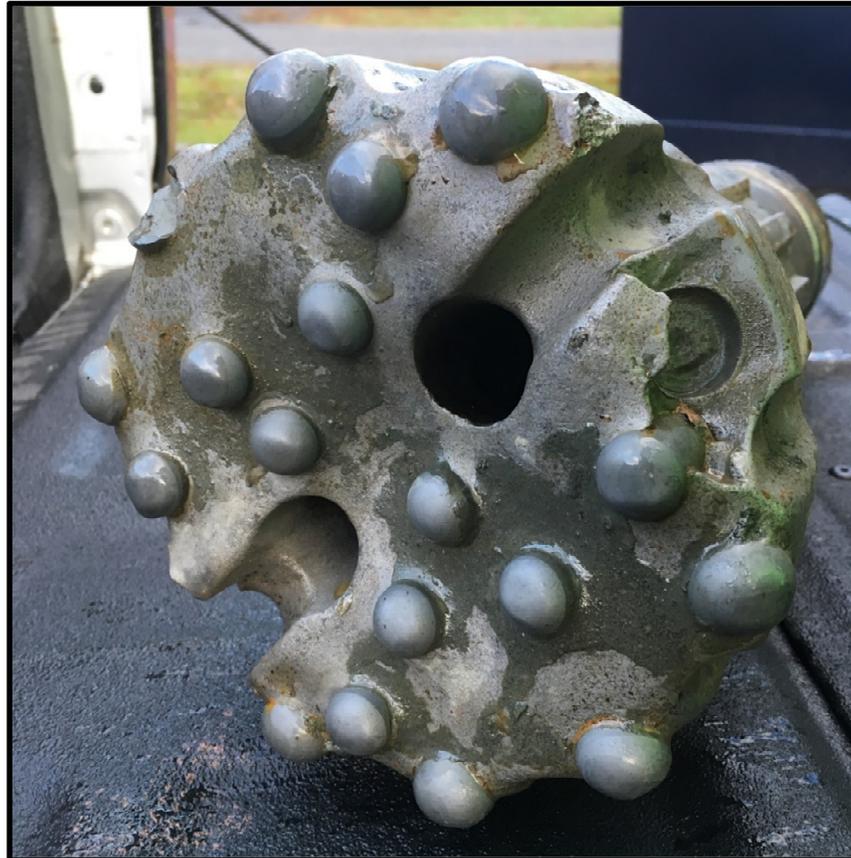
Failure: Carbide missing, Matrix damage

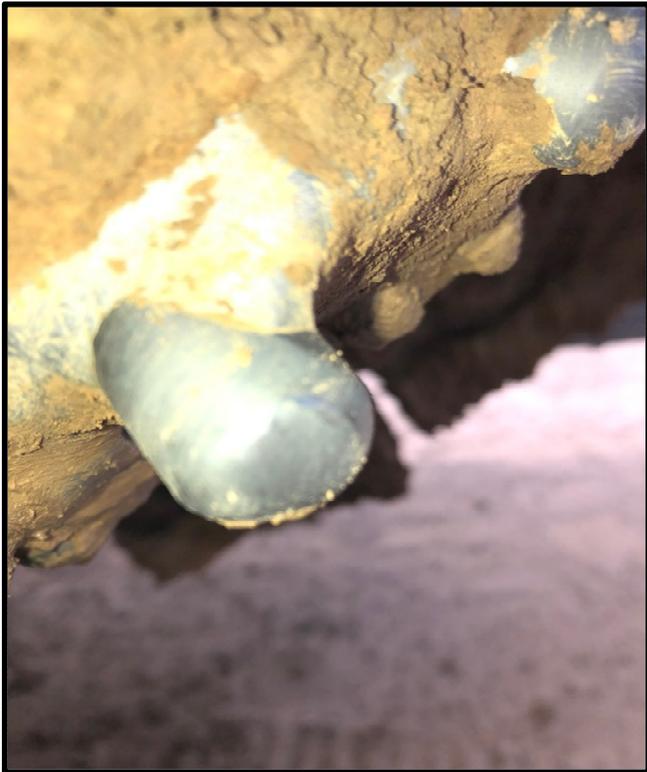
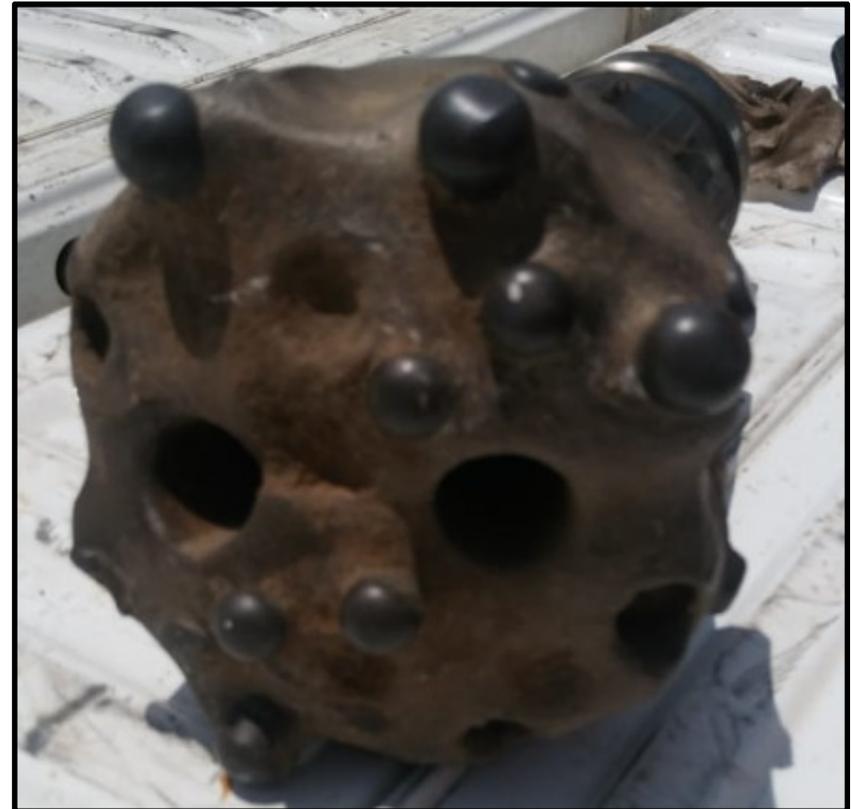
Failure: Excessive steel wear

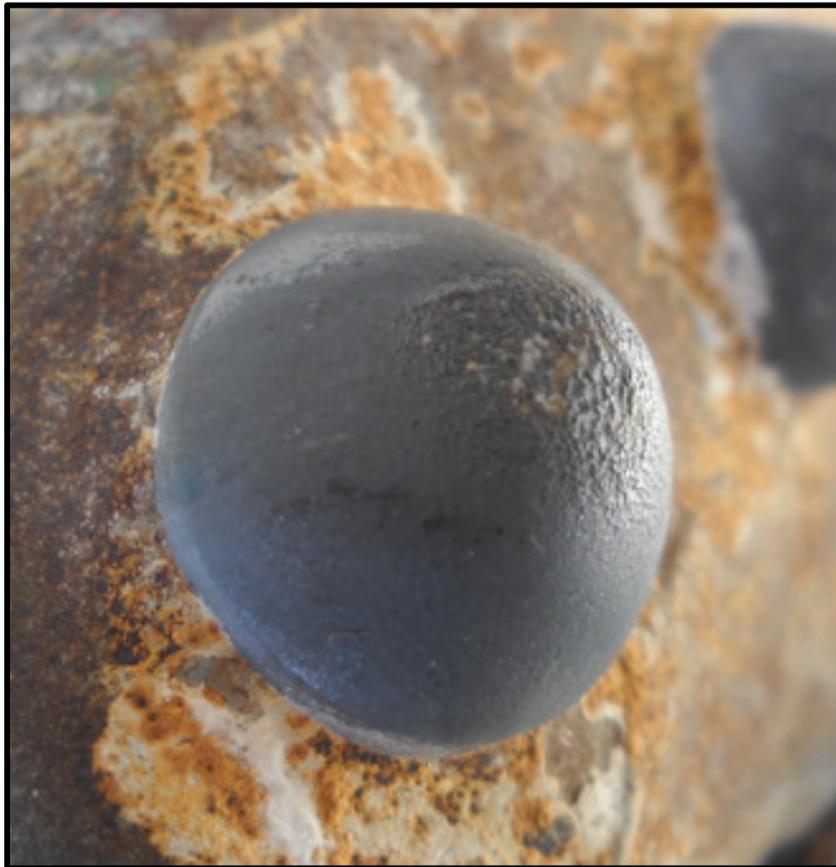
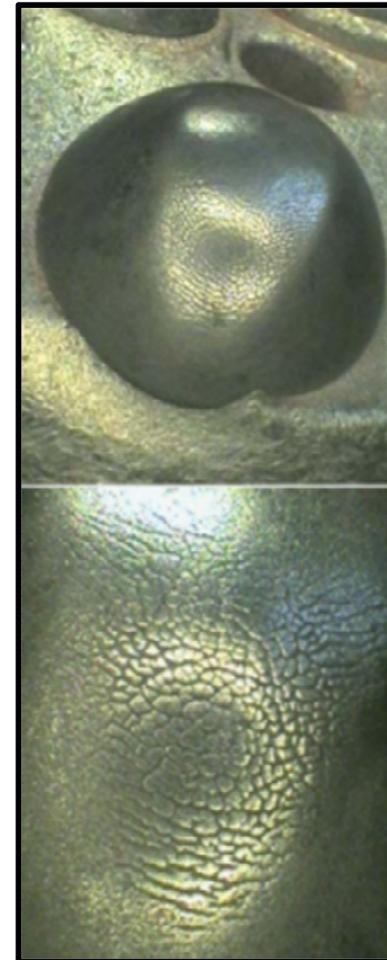
Failure: Snake skin wear

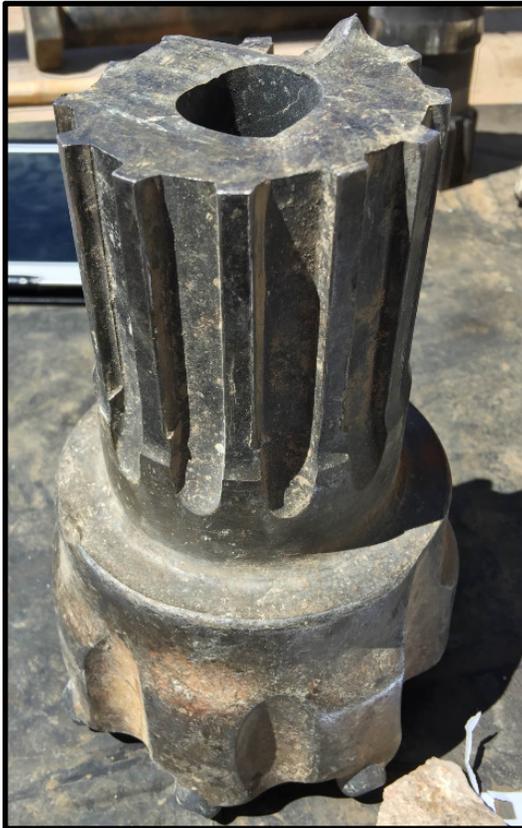
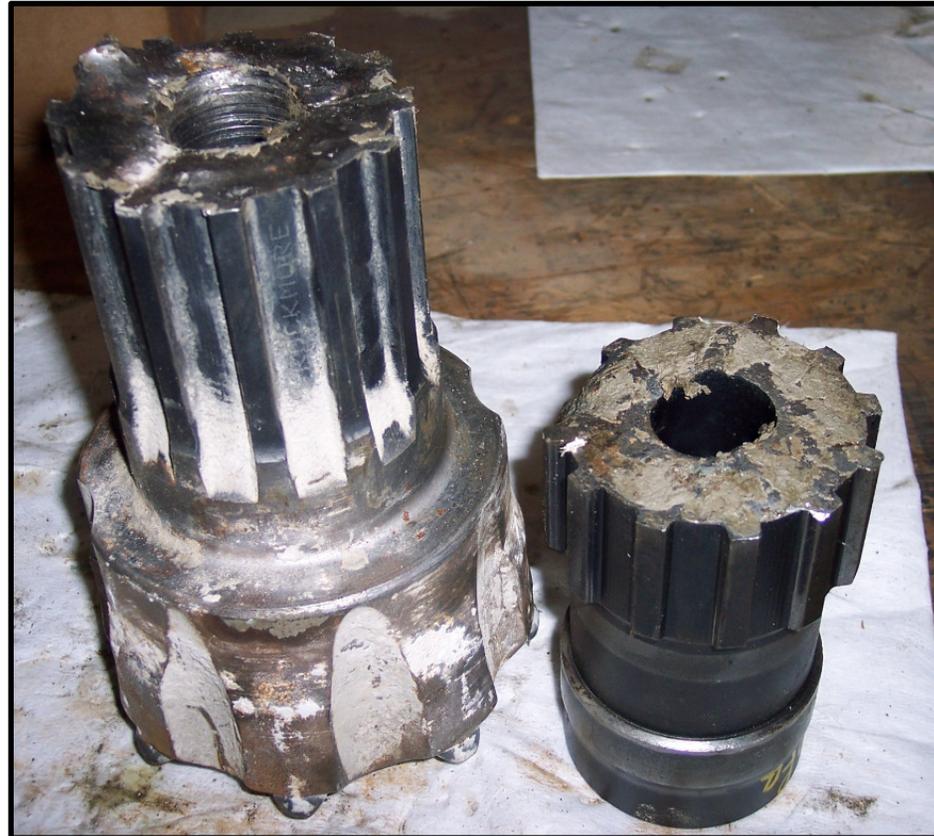
Failure: Broken shank across splines

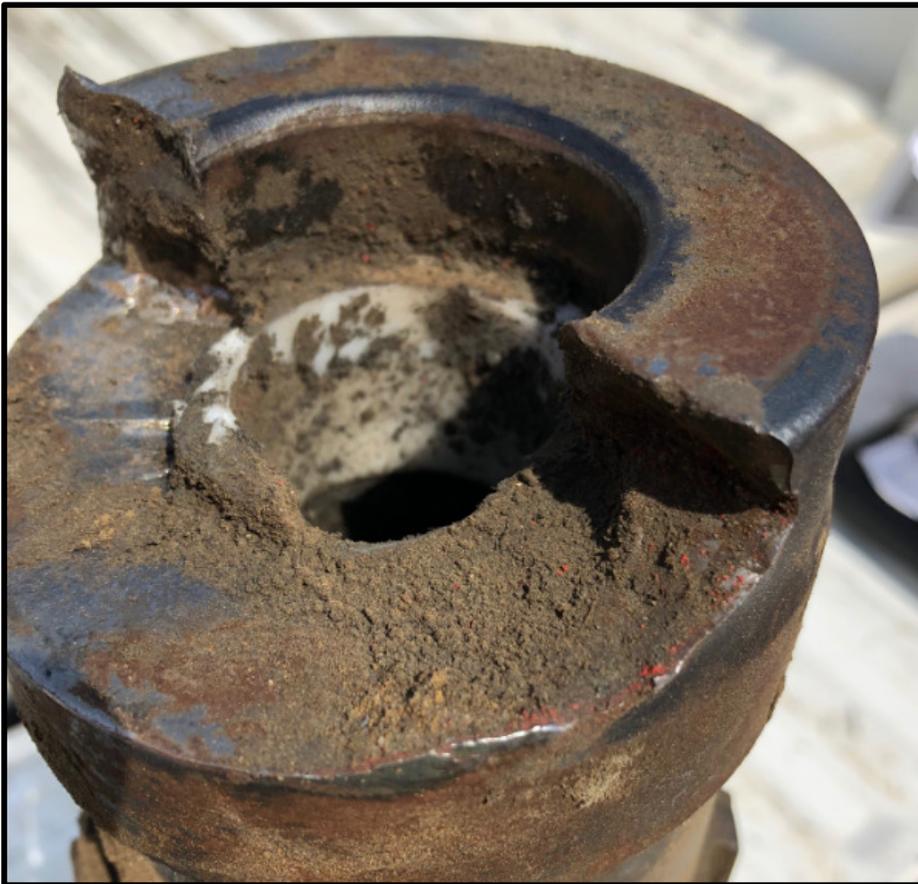
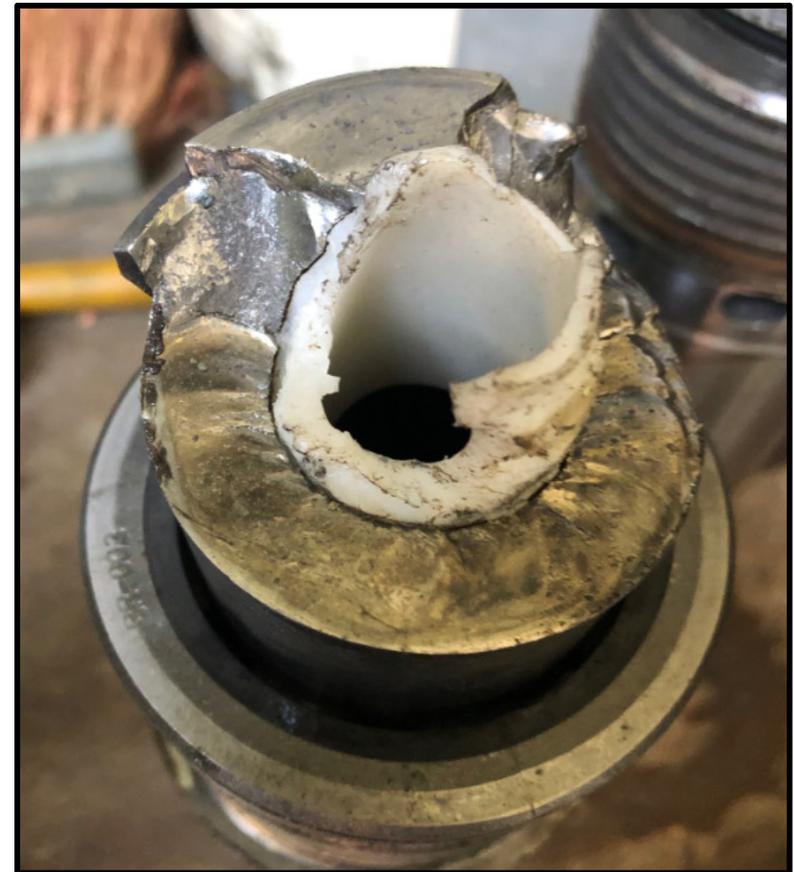
Failure: Broken striking face

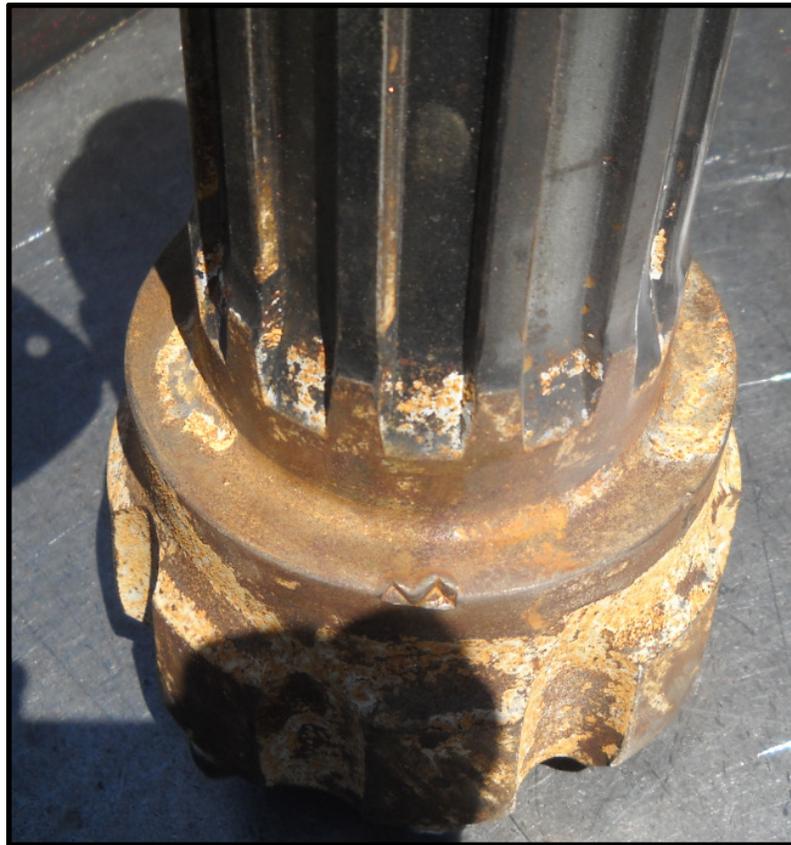
Failure: Shoulder damage

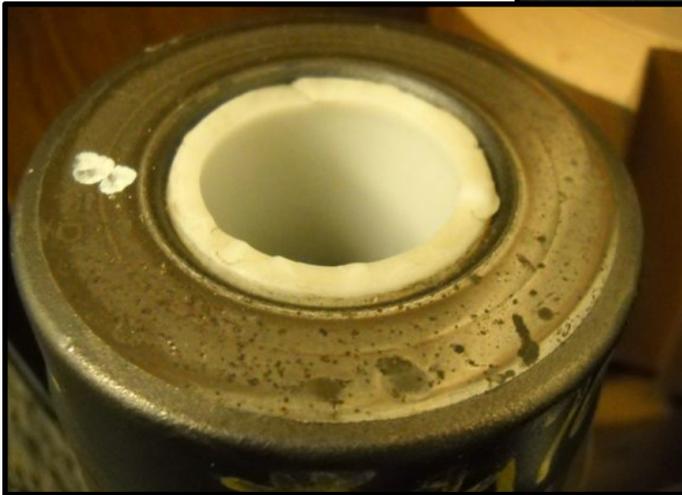
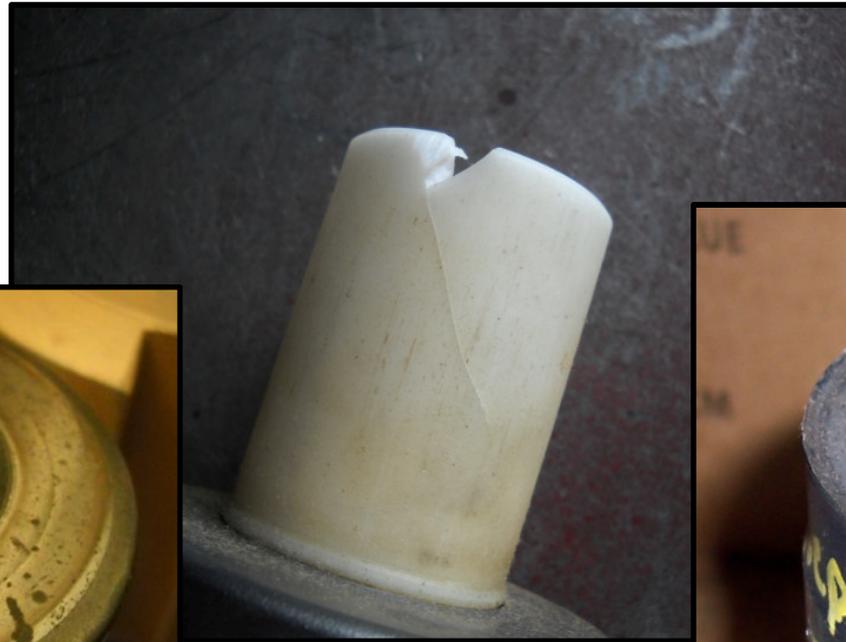
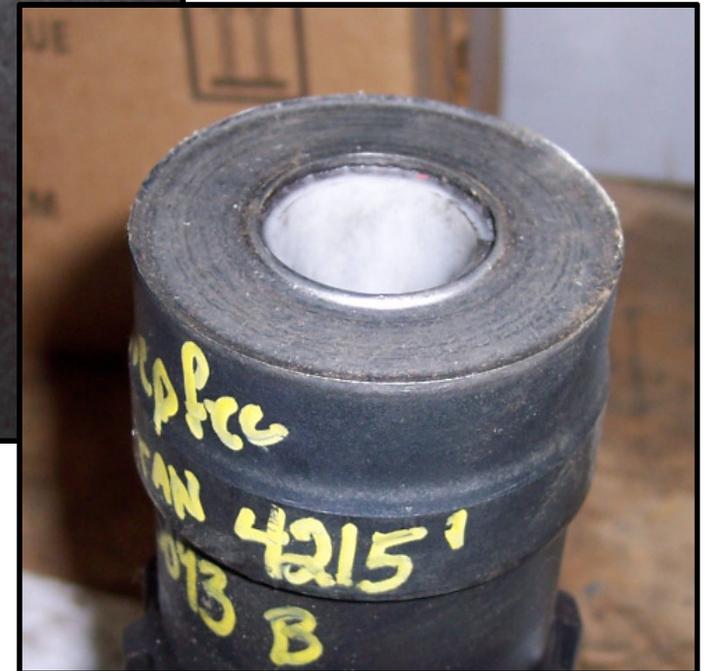
Failure: Broken foot valve
