R O C K M O R E
I N T E R N A T I O N A L

Failure Troubleshooting

DTH Drilling Tools - *Bits and Hammers* -

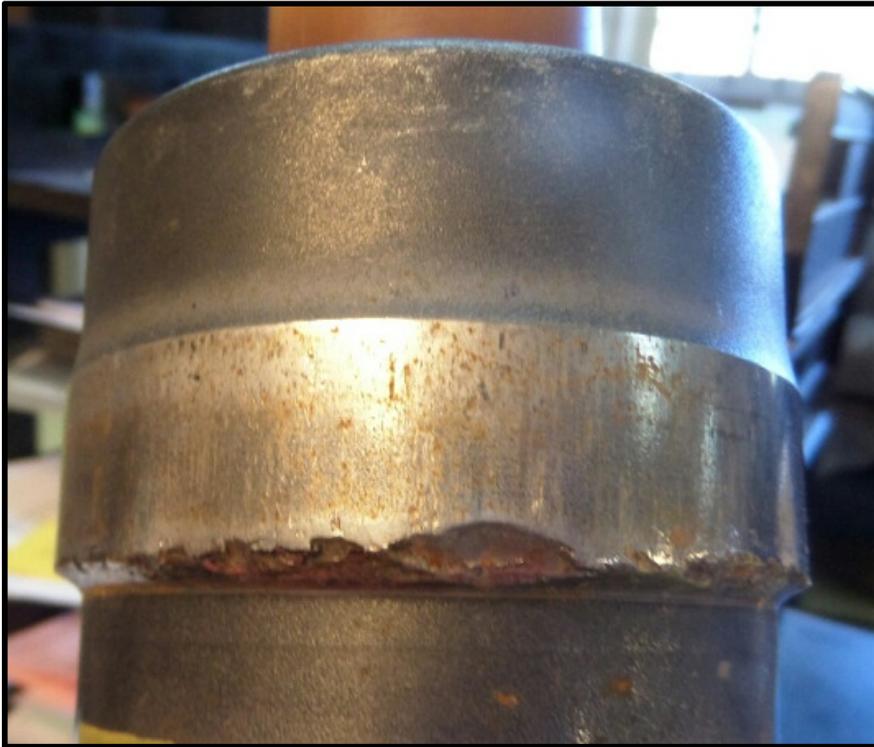
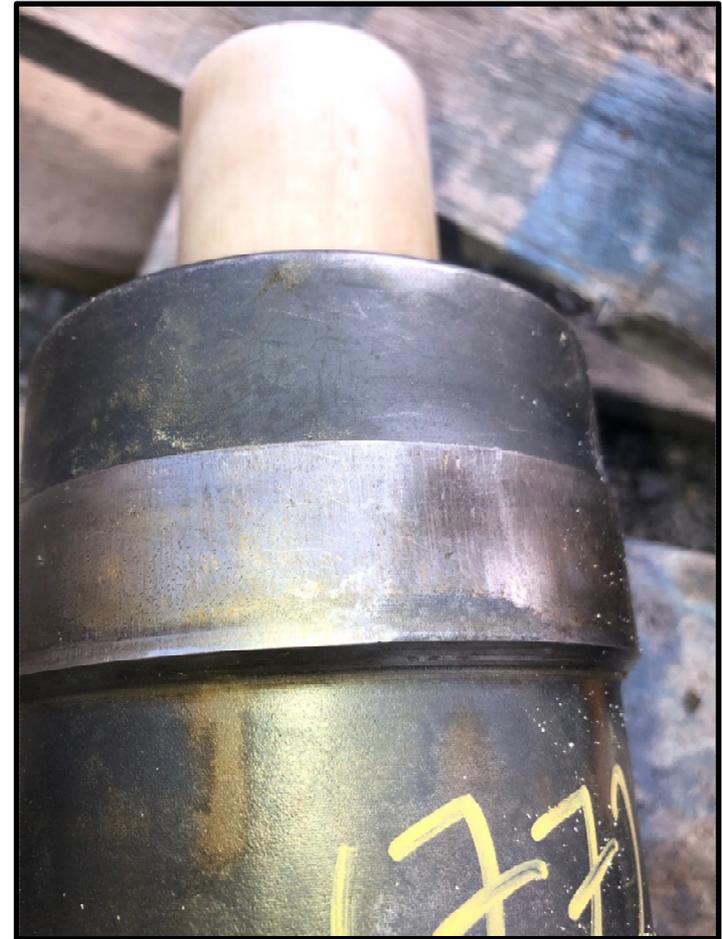
Failure: Bit Retaining Area Damage

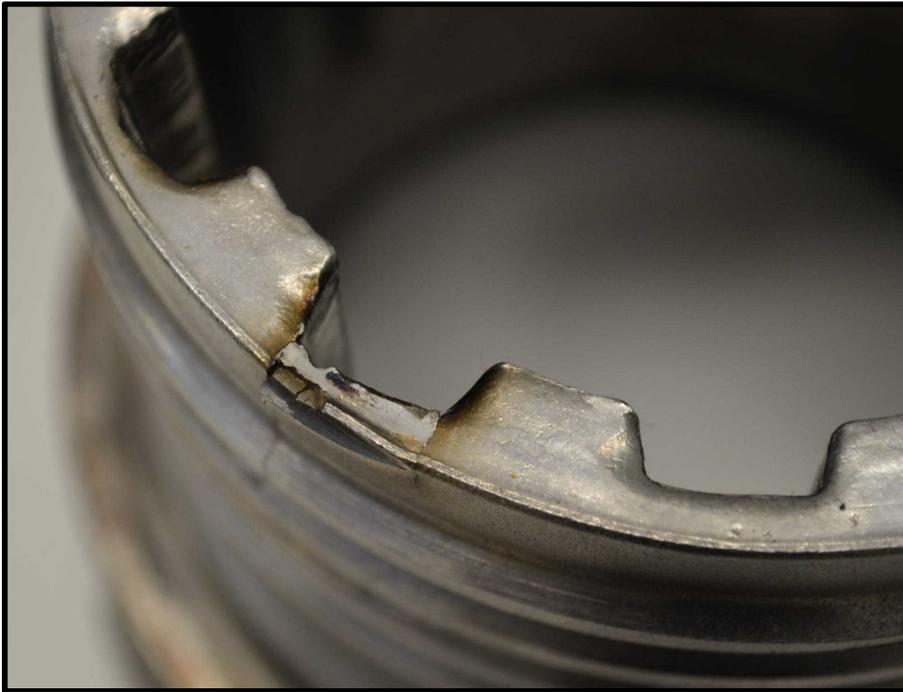
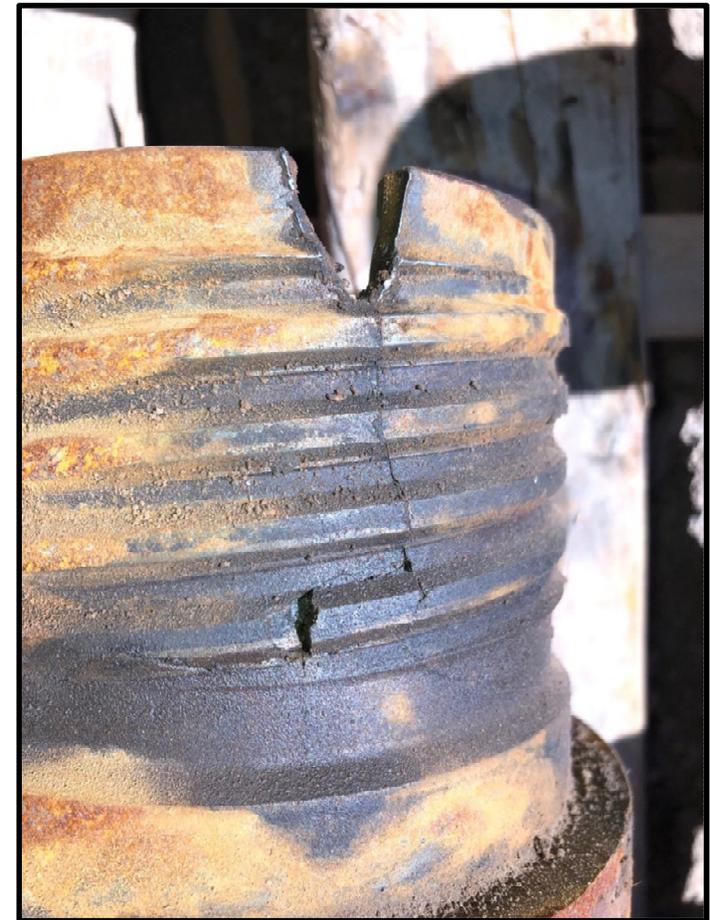
Failure: Broken Driver Sub

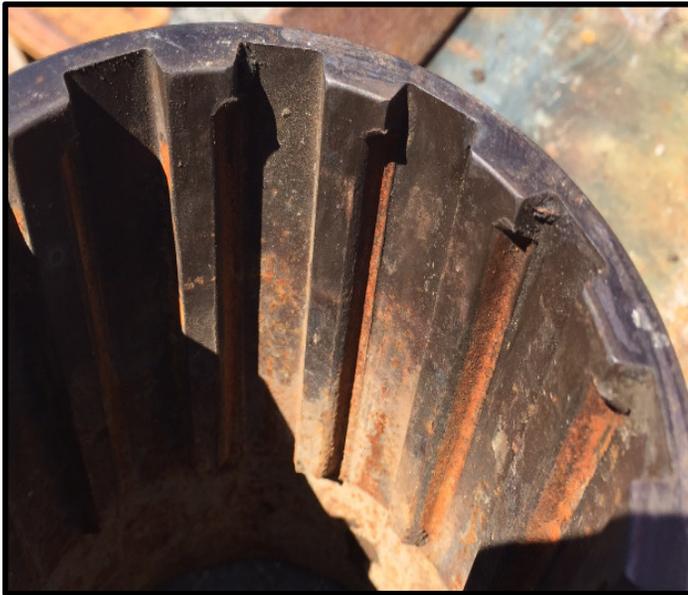
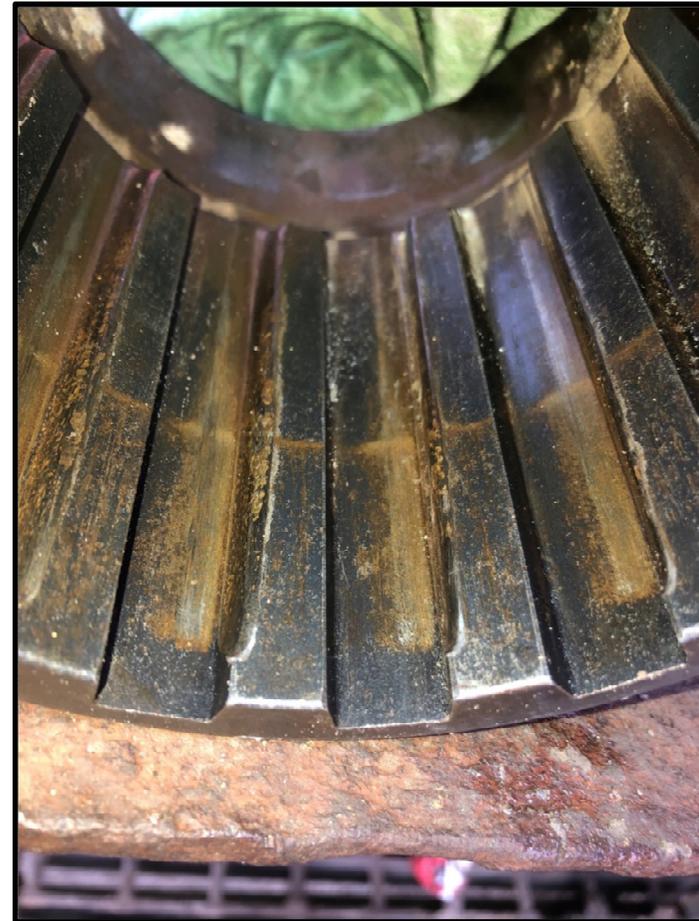
Failure: Excessive on Driver Sub splines

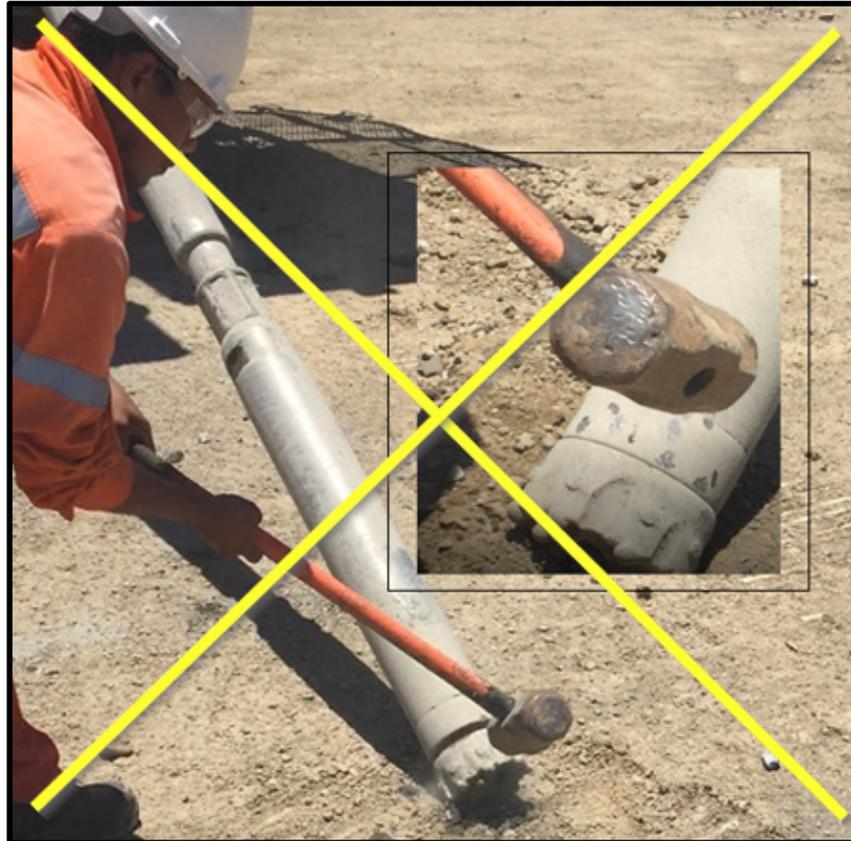
Failure: Cracked Driver Sub

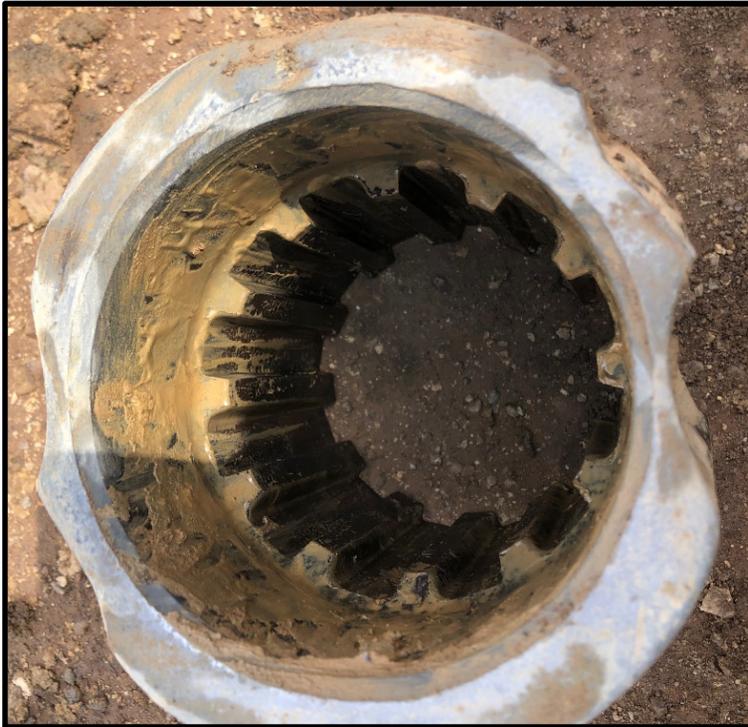
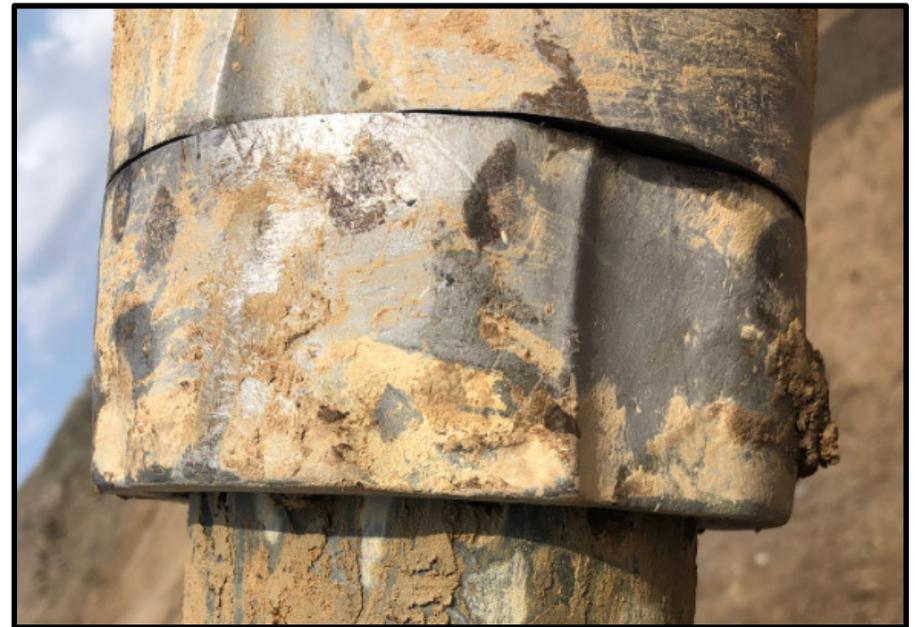
Failure: Excessive wear on Driver Sub

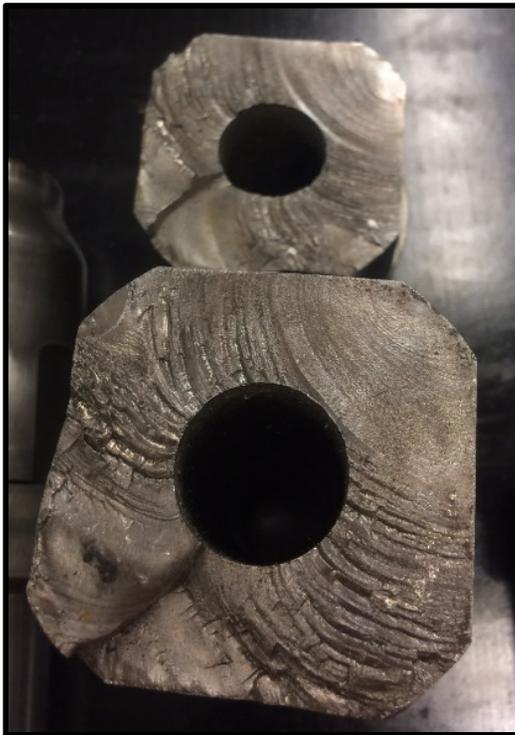
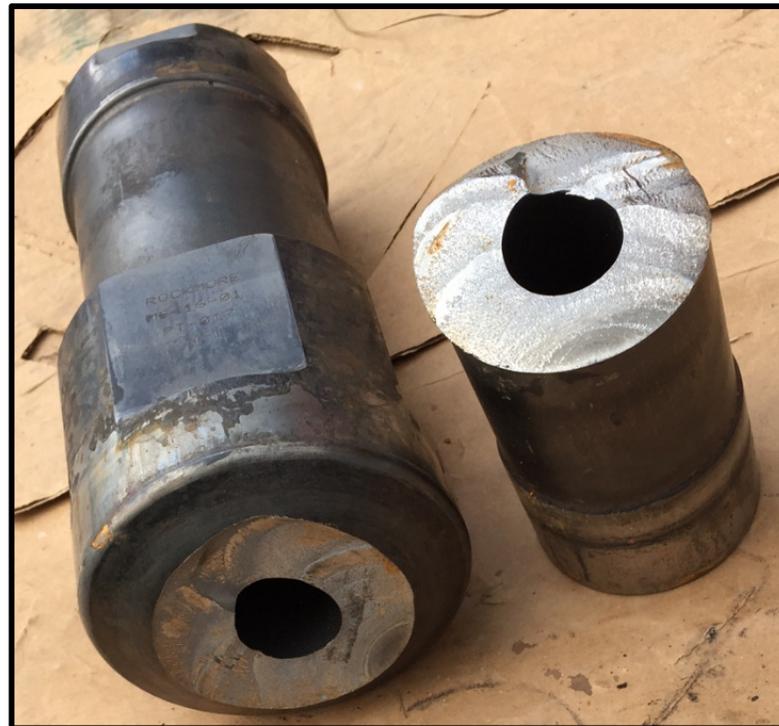
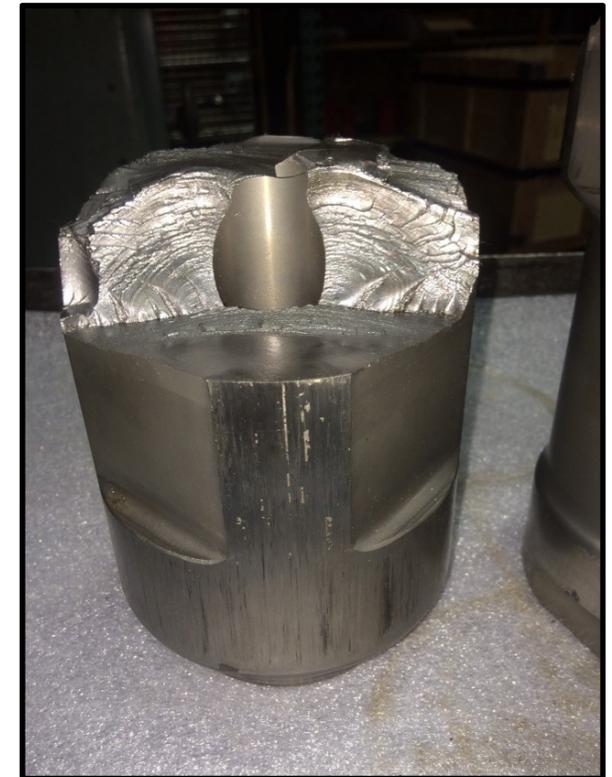
Failure: Broken piston

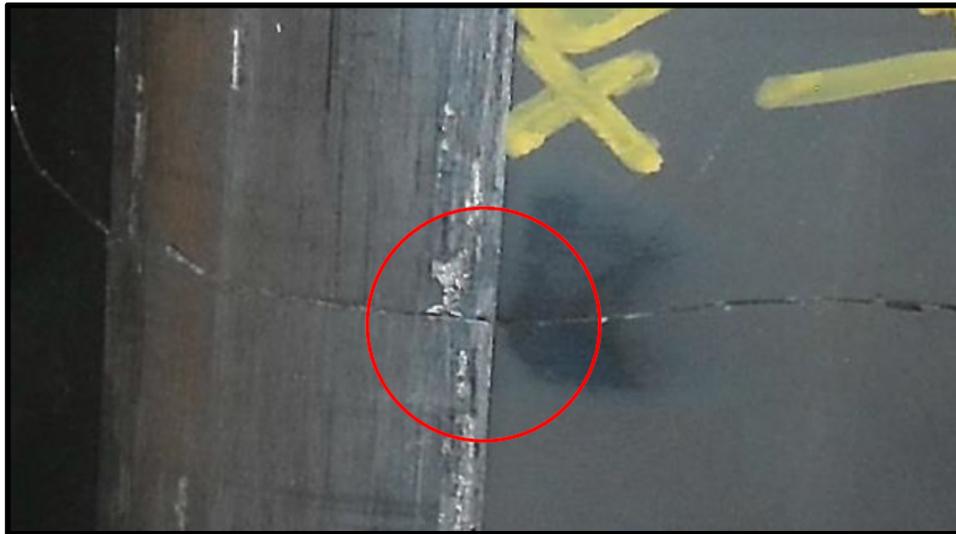
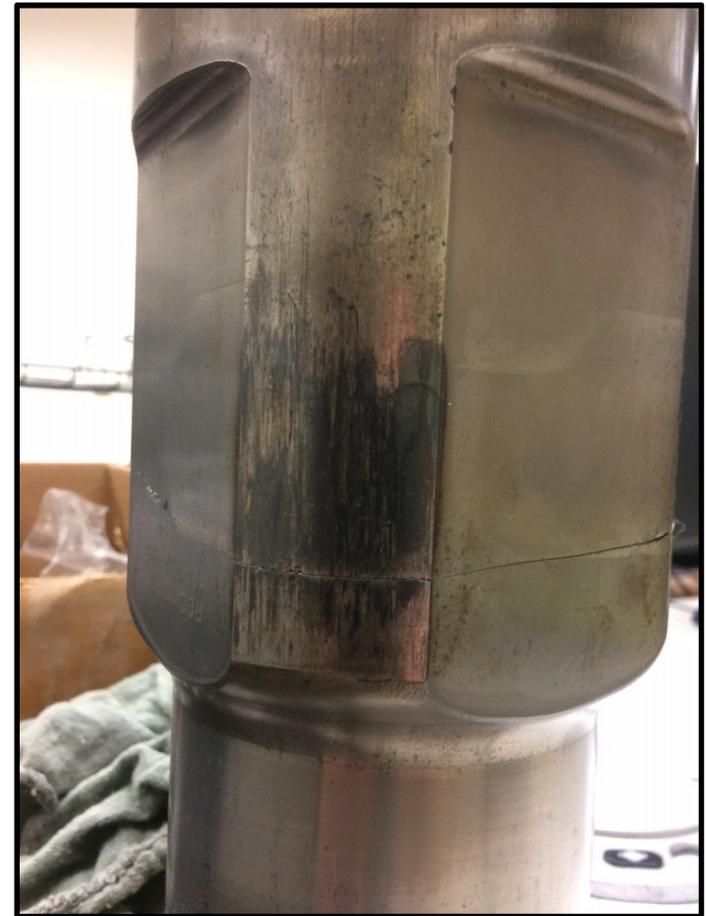
Failure: Piston cracked

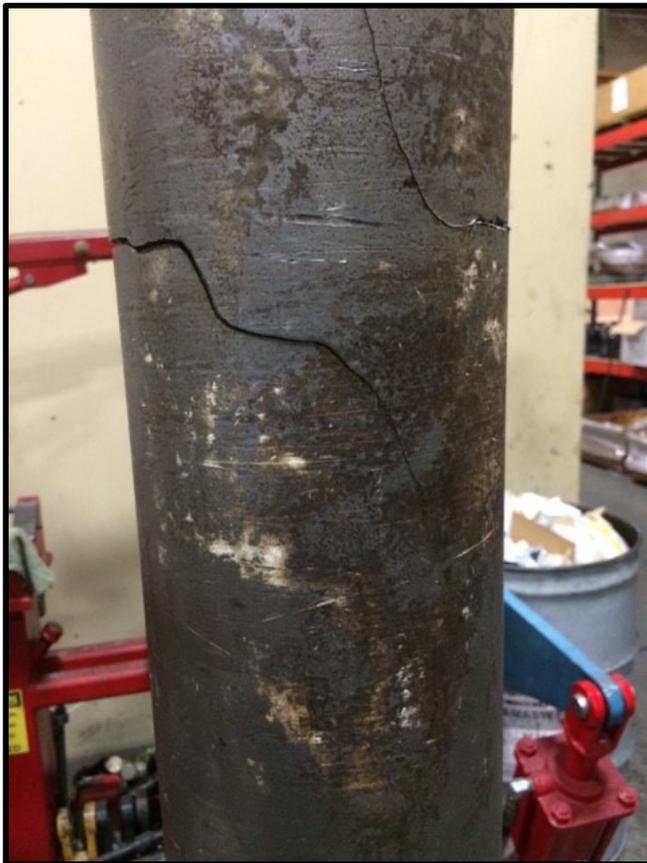
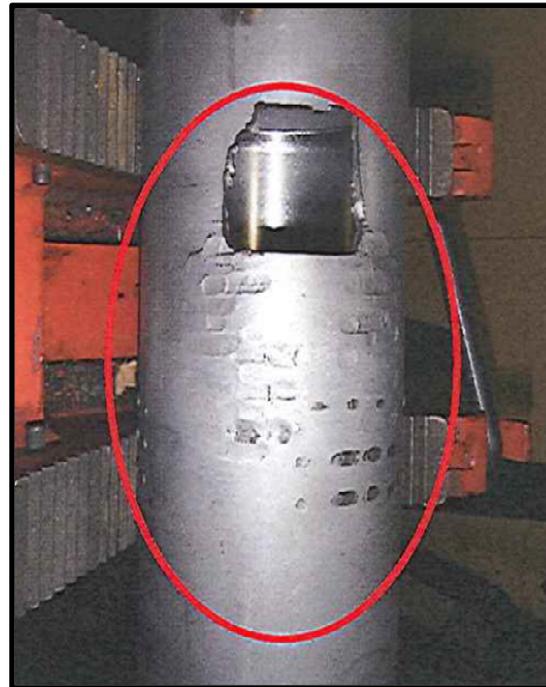
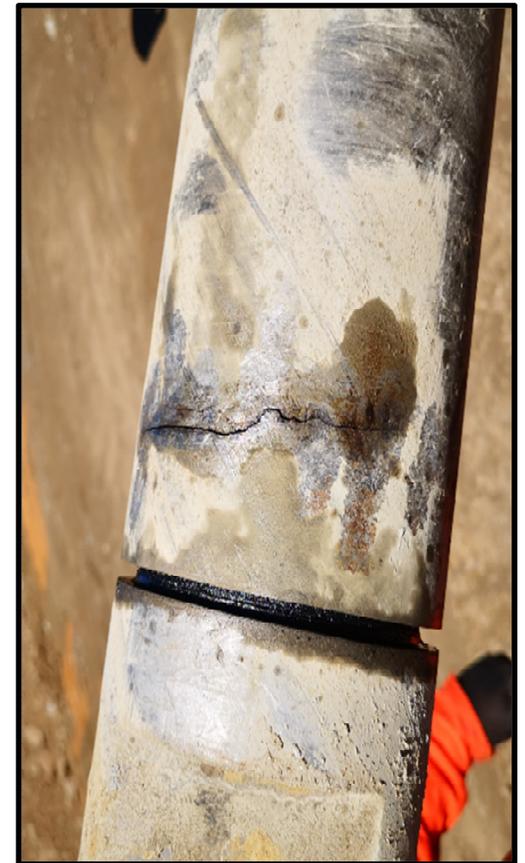
Failure: Cracked wear sleeve

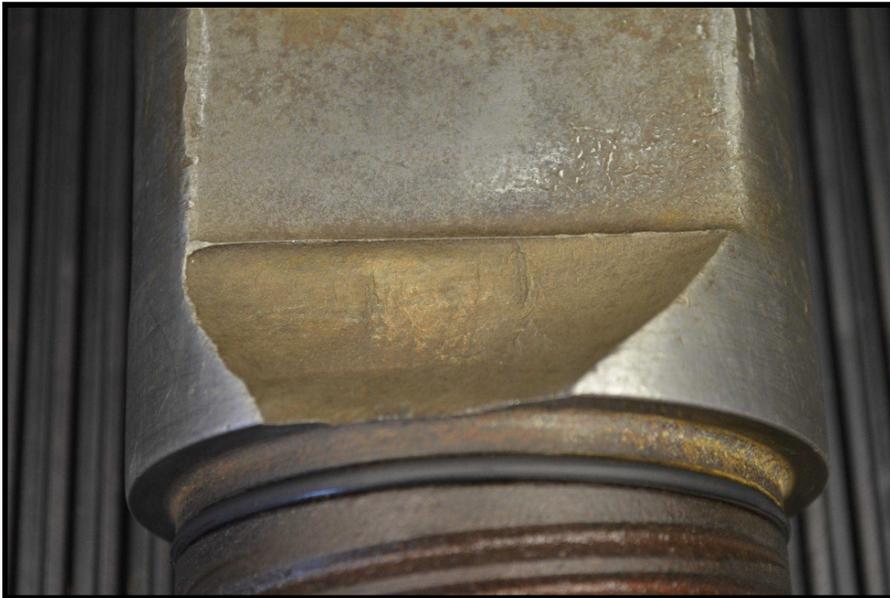
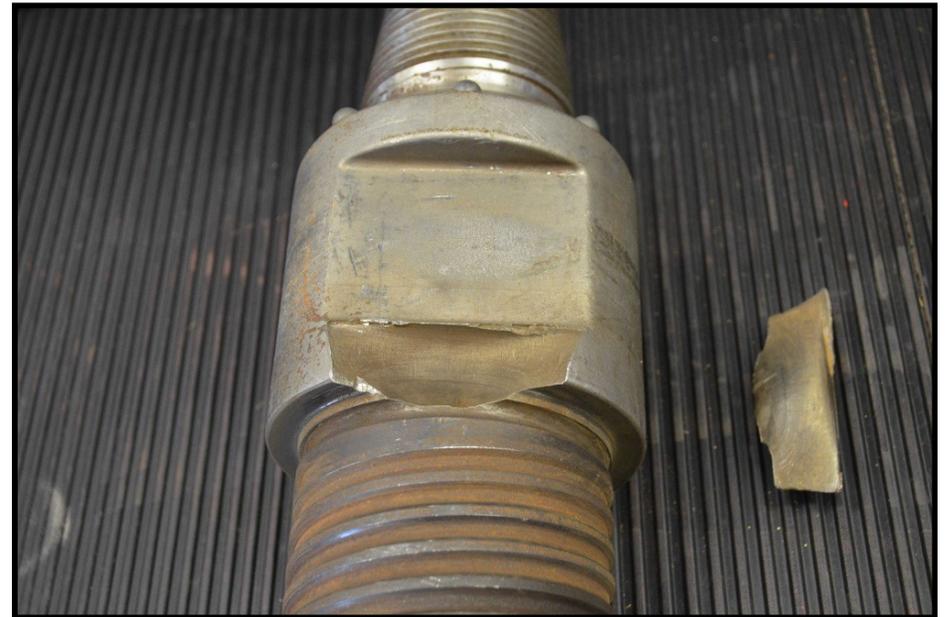
Failure: Broken Top Sub

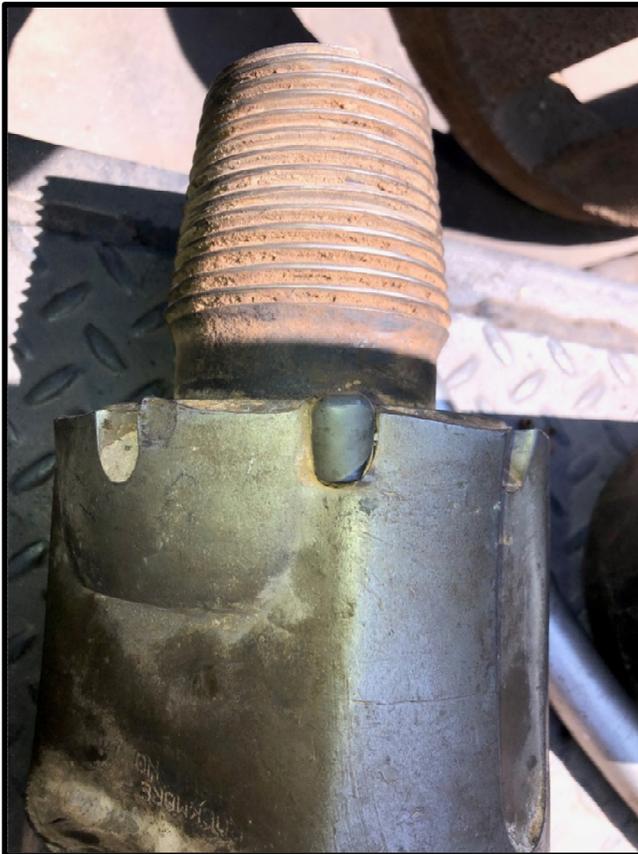
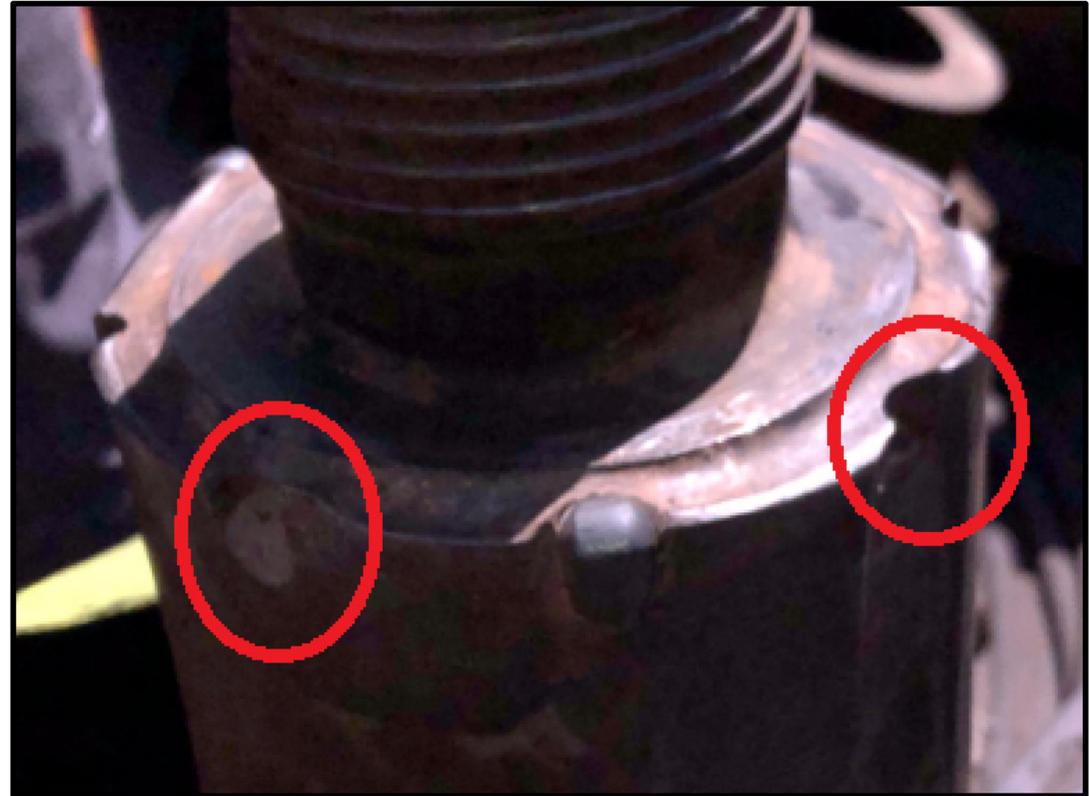
Failure: Top Sub missing Reaming buttons
