R O C K M O R E
I N T E R N A T I O N A L

Failure Troubleshooting

DTH Drilling Tools - *Bits and Hammers* -

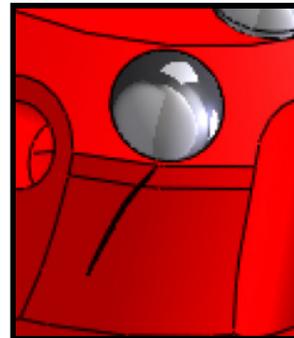
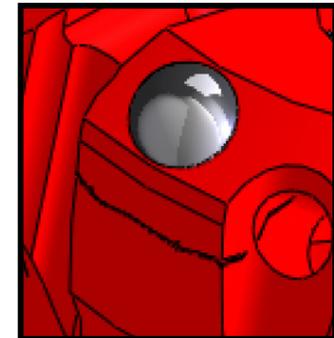
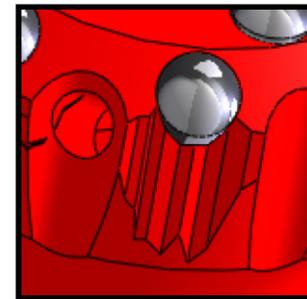
Crack in body near carbide; Crack in body originating from bottom of carbide socket; & Carbide intact, surrounding matrix missing

Action required:

- Return to manufacturer for analysis

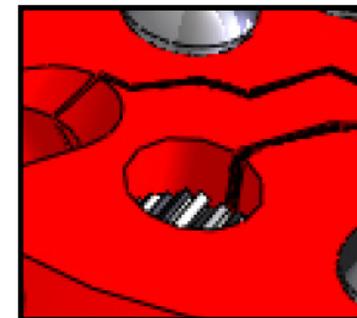
- Over drilling in a non-abrasive rock, such as limestone
- Improper carbide grinding intervals
- Excessive carbide protrusion from poor grinding practices

- Inspect carbides frequently for snake skin wear pattern (see page 16)
- Shorten grinding intervals when drilling in non-abrasive rock
- Sharpen carbides when dull or micro cracks begin to form, following proper carbide sharpening procedures
- When sharpening carbides do not remove excessive body; carbides should not protrude more than 3/4 of the carbide diameter

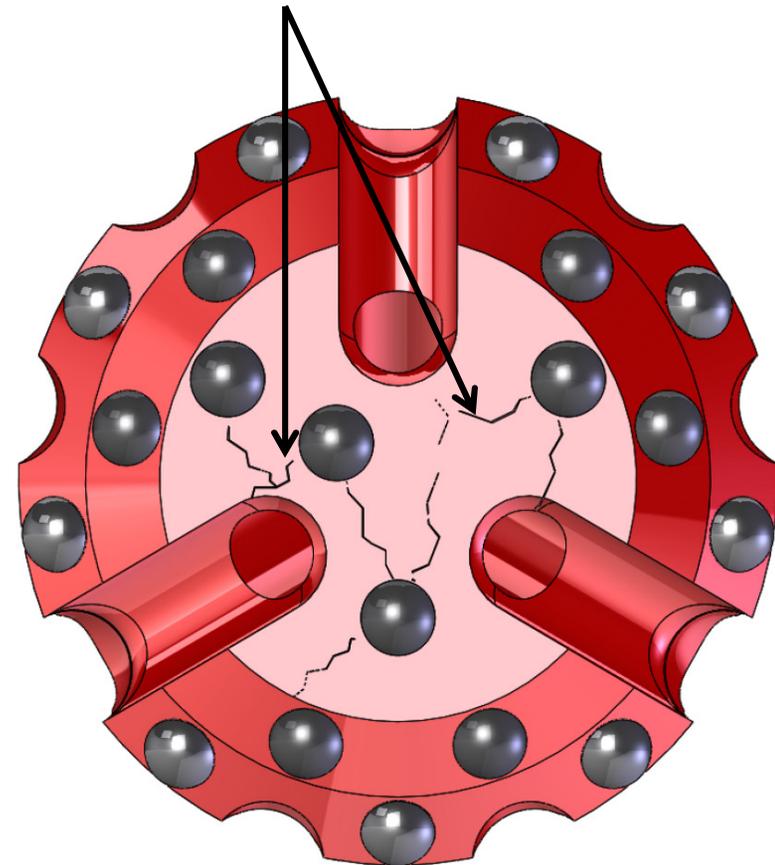
Problem: Face cracking

Action required:

- Reduce feed force until the carbides engage in the rock
- When drilling deep holes, “pull back” may need to be used to compensate for the weight of the drill string pushing on the bit excessively

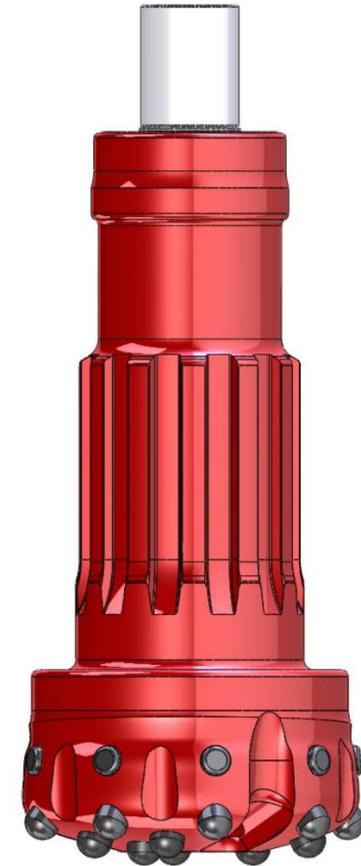
Body wash – Excessive steel wear on the
bit body and bit face

Cause of problem:

- Drilling in extremely abrasive conditions

- Slow rotation as much as possible to help create larger cuttings that will flush up the hole more efficiently
- Maximize flushing
- Use drilling foam to help flush or lift the rock cuttings
- Clean drill holes regularly
- Adjust hammer choke to reduce up-hole velocity of rock cuttings

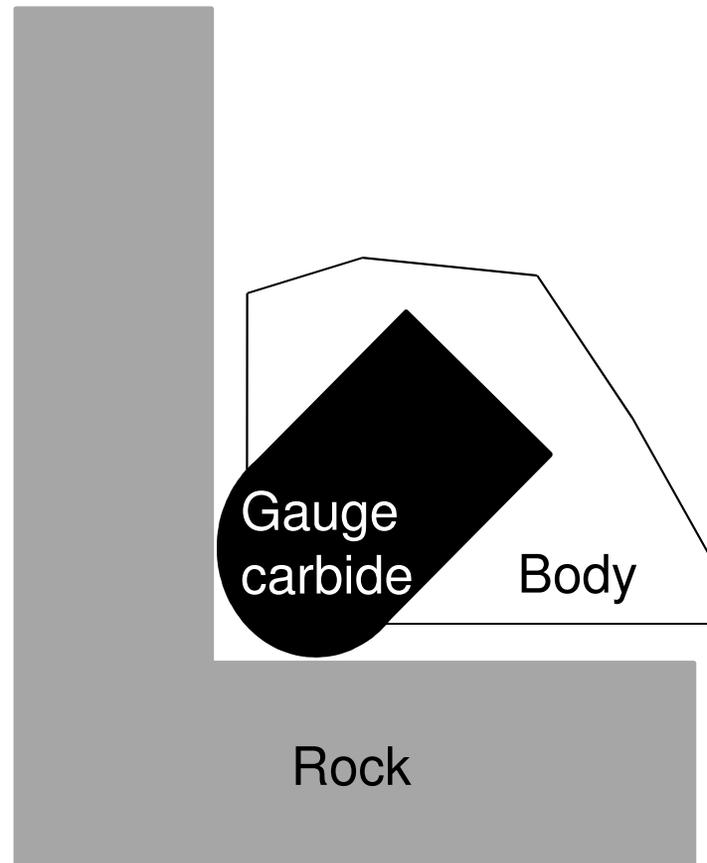
Diagram 1 of 2

Carbide buttons are designed to resist compressive forces not shear forces.

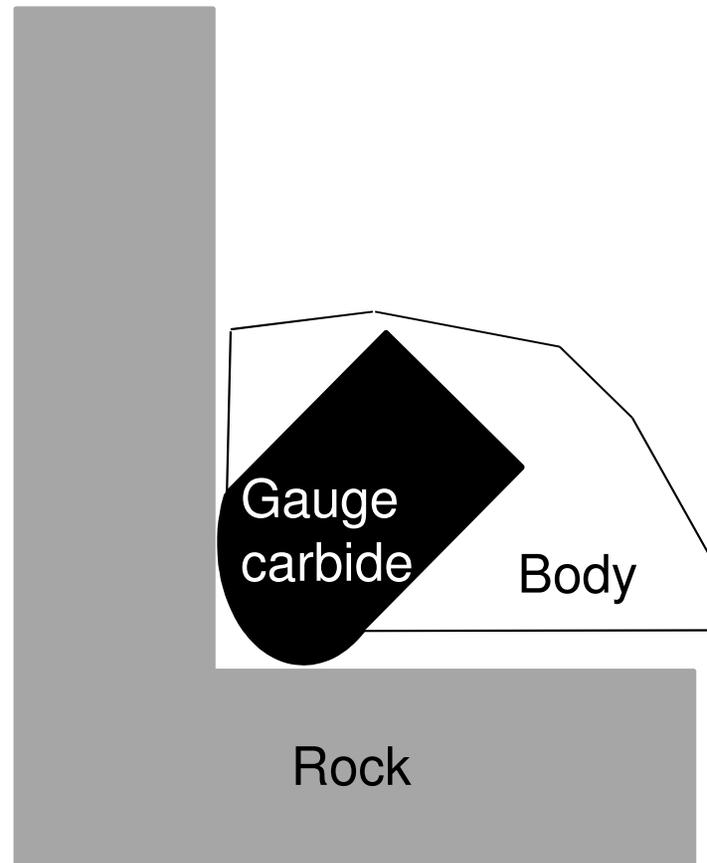
Diagram 2 of 2

As the carbide buttons starts to wear, they develop a flat surface. As the flat enlarges the load on the carbide changes from compressive to shear.

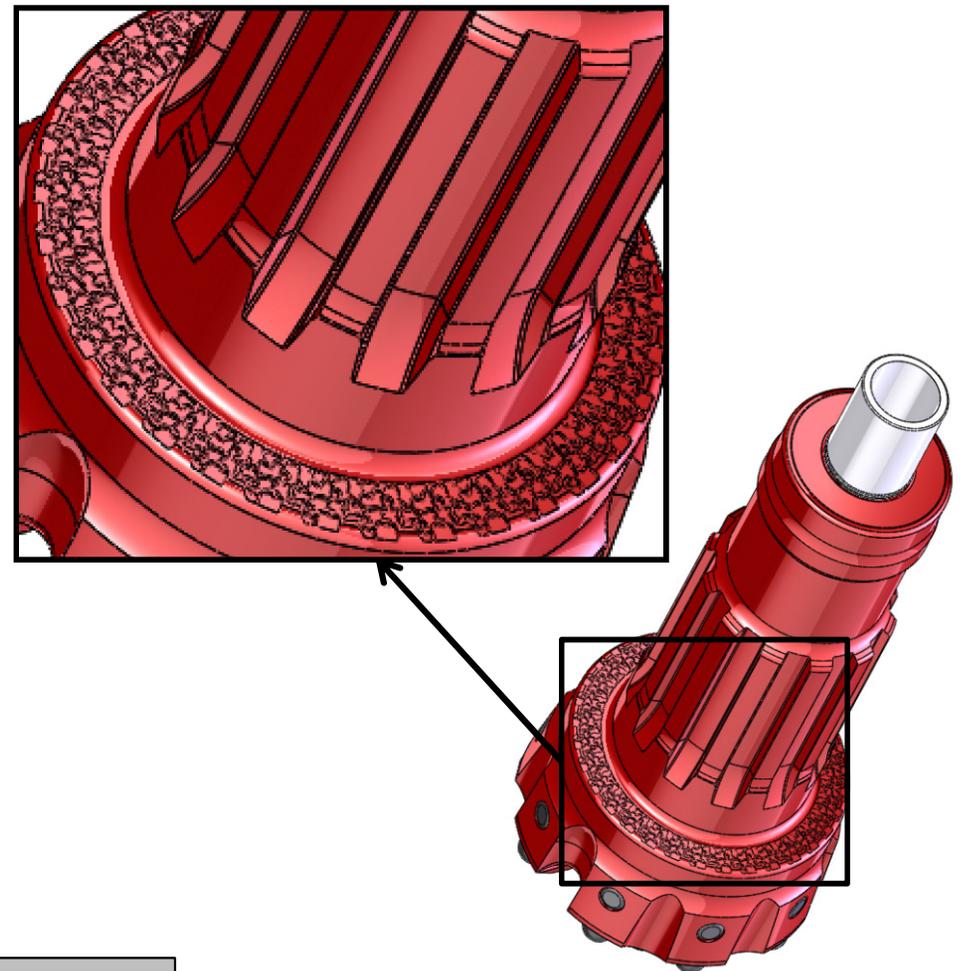
Problem:
Shoulder damage

Action required:

- Adjust feed force to keep the carbide engaged in the rock. More will need to be applied when drilling into soft rock. Less will be needed as drill pipe is added and weight from the drill string increases the feed force.

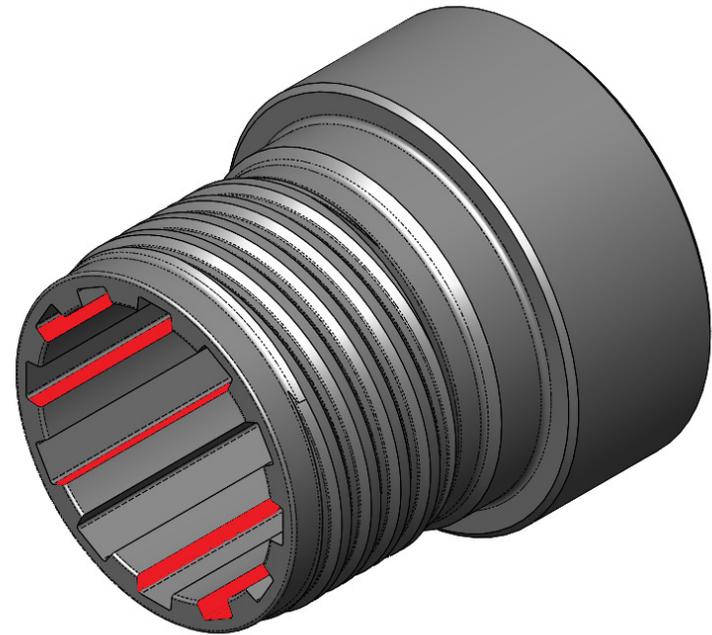
Failure: Excessive drive sub spline wear

Action required:

- Use the correct type and quantity of hammer oil
- Increase weight on bit
